## Bulletin CQB 01-07

**Subject:** Brake service on Ford light duty trucks that have not complied with the lug nut recall notice

**Vehicles Involved:** 1997-98 F150 pickup, 1997-98 Expedition, 1998 F250 pickup & 1998 Navigator.

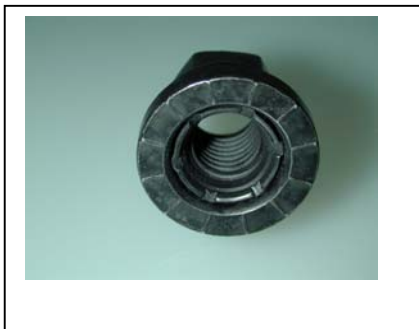
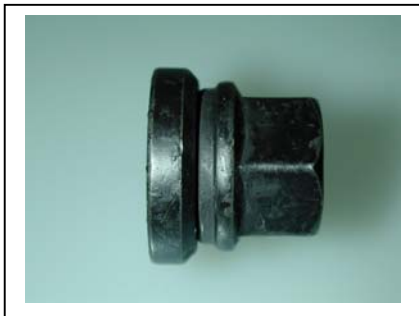
**Condition:** Vehicle comes into your shop for service which requires removal of the wheels, but the customer still has the old style (recalled) lug nuts and the centering O-ring on the hub. Note: It is commonplace for owners not to have complied with the lug nut recall on these vehicles.

**Repair Procedure:** Ford replaces the silver lug nuts with a dark or black lug nut. The type of plating on the replacement lug is different allowing the lug nut to properly apply the correct holding and subsequent clamping force on the wheel. Note that Ford did change the torque specification on the original (silver) lug nuts to factory torque (100 lbs.ft) then and additional 1/8 to 1/4 turn. This was with the rubber O-ring in place.

If you service a vehicle that has not had the lug nuts replaced it is recommended that you do not remove the O-ring which is part of the recall work and reuse the old silver lug nuts. Use the above torque specifications while using the O-ring, inform the customer of the recall and note the condition on the work order. New O-rings are no longer available from the dealership, just the new style of lug and nut. This creates a situation, when you remove a wheel, where you may have silver lug nuts and an old O-ring which is damaged. In this situation it is generally recommended that you obtain the new style of lug nuts or locate an O-ring to use with the old style of lug nut until the customer has the lug nuts replaced under the recall. Up to mid-2000 O-rings were packaged with new rotors and drums for these vehicles. This presently is the only source for a replacement O-ring. Don't install the silver lug nuts without an O-ring this procedure has never been authorized by Ford.
