Subject: Diagnosing and Measuring Rotor Run-out.

Vehicle Involved: All vehicles with hub-less rotors.

Condition: Pedal pulsation after brake service.

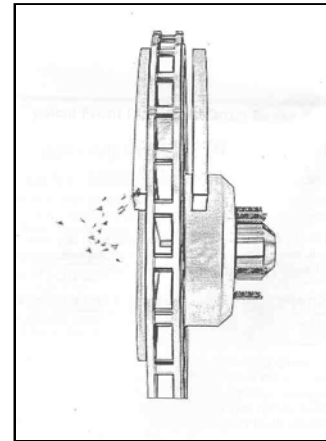
Fig.1

2. What are the effects of excessive lateral rotor run-out? With

excessive run-out, the rotor wobbles as it turns (Fig.1). Uneven rotor wear occurs with the brakes not applied causing rotor thickness variation. Thickness variation causes:

- Brake pedal pulsation
- Dissatisfied customers
- Comebacks

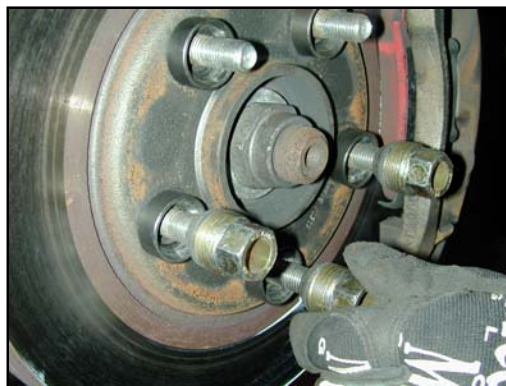
Fig.2

3. How do I check rotor run-out? (Fig.2)

- Inspect unitized hub and bearing for excessive play
- Clean hubs and rotor hat
- Install conical cones/washers
- Torque lug nuts in sequence
- Secure dial indicator

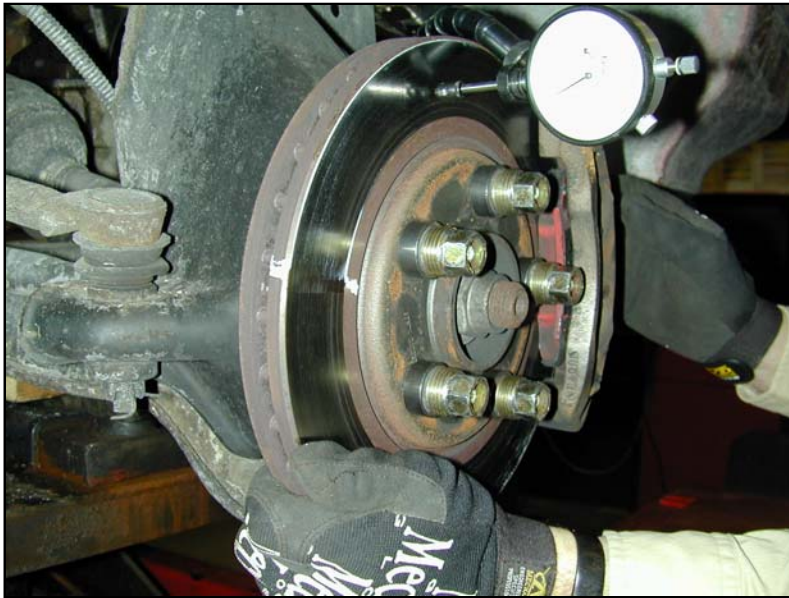
Fig. 3

A new rotor or a good resurfaced rotor placed on a hub that has run-out may cause a comeback. With a little extra care and time, a technician can index the rotor to hub. This process is very easy, and in most cases the run-out specification can be attained.

Index Rotor To Hub

* Begin the process by cleaning the hub and rotor of rust and burrs. Identify one of the wheel studs with a yellow marker, torque the rotor to the hub and check run-out. If the run-out is out of specification, remove the lug nuts and move the rotor one-wheel stud to the right. Torque the lug nuts and re-check rotor run-out. Repeat this sequence until the least amount of run-out is attained. Fig.3
