## Bulletin CQB 03-07

**Subject:** Water intrusion may cause rear wheel bearing noise.

**Vehicle Involved:** The following models equipped with ABS:  
1999-2001 Mitsubishi Galant  
2000-2001 Mitsubishi Eclipse  
2001 Mitsubishi Spyder

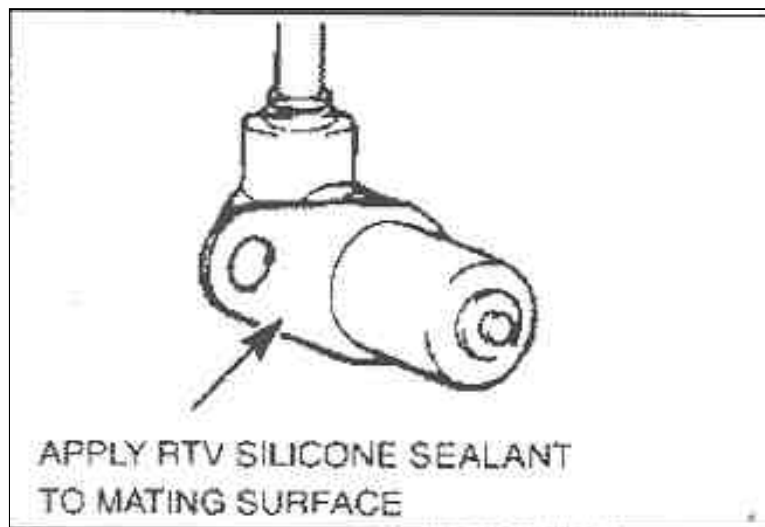
**Condition:** Rear wheel bearing noise or damage may result from water intrusion through the ABS sensor to knuckle. When servicing rear wheel bearings, rear ABS sensors, or rear knuckles the procedures in this bulletin may help to improve sealing.

**Repair Procedure:** Vehicles manufactured after 5-4-01 are equipped with rear knuckles that have a machined groove for an o-ring at the ABS speed sensor mounting point. Install the o-ring seal in the groove before installing the ABS sensor to the knuckle. Be sure the o-ring is properly seated in the groove. On vehicles built before 5-4-01 or with vehicles that do not have the o-ring seal, install a light coating of RTV silicone sealant to the mating surface of the ABS speed sensor mounting point. See illustration below. Note: excessive amounts of RTV may actually "lift" the sensor increasing the non-adjustable air gap. This in turn may cause false ABS modulation.
