Bulletin CQB 03-20

Subject: Intermittent scraping noise from rear of vehicle. Redesign of Spring Clips on Parking Brake Shoes provides better support, and reduces noise.

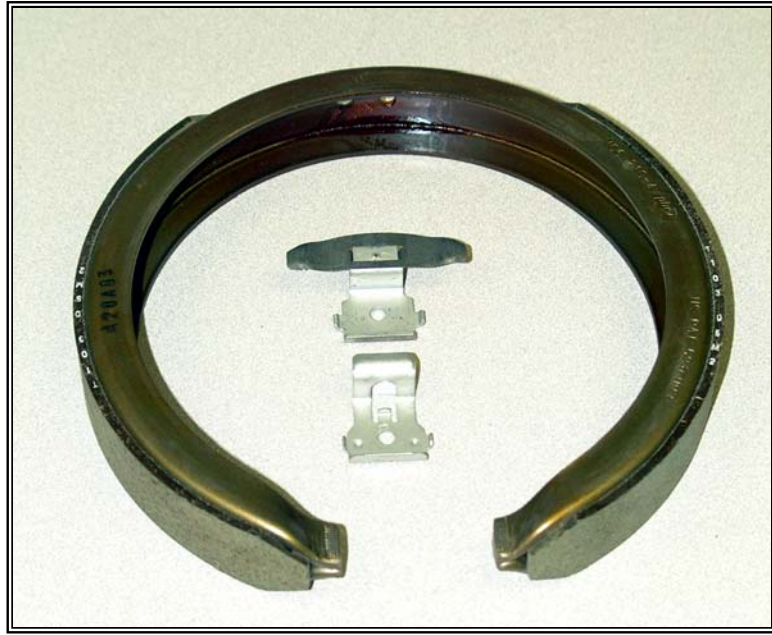
Condition: GM made a running change to the design of the spring clips in the 781 brake shoe sets. We have also made the same change. The new spring clip design has a wider contact area with the parking brake band. (See illustration page 2). This design improvement provides increased support of the brake band, which also reduces noise.

Repair Procedure: Detailed installation instructions are included with the new parking brake shoes. Note: it may be necessary to relieve the tension on the parking brake cables by loosening the nut at the equalizer. When removing the rotor, slowly turn the brake rotor and pull outwards simultaneously, keeping the rotor square to the axle. If the rotor jams during removal, do not force it off. Push the rotor back to its original position and attempt again. Forced removal of the rotor may damage the parking brake hold down spring and shoe. The rotor may not be easily removed because of a rust ridge built up on the outside edge of the drum and hat section of the rotor. After removal of the rotor, clean the rust ridge from the drum section of the rotor by using a grinding stone. The parking brake surface does not have to be resurfaced. Rear brake pulsation cannot be identified with this type of brake system by applying the parking brake while moving. Minimum thickness of the parking brake shoe lining in any given spot is 0.060 inches.
