Solver[™]
BULLETIN

BULLETIN: 25933

Front Wheel Drive Lower Ball Joints

General Motors

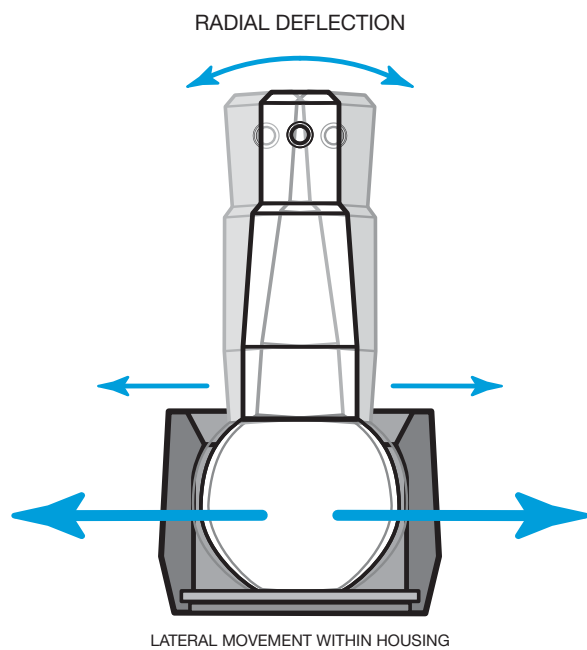
Premature ball joint wear

- Lateral deflection (side to side) loading causes excessive wear in ball joint.
