PROBLEM *Solver*[™] BULLETIN

BULLETIN: 25881

Tie Rod End Failures

General Motors 1500/2500/3500 Trucks

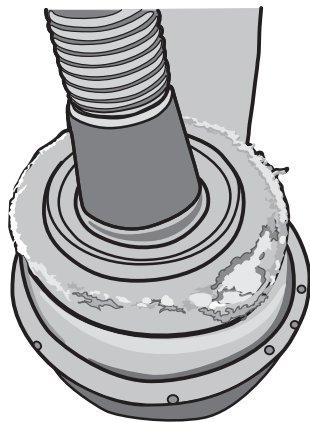
OE tie rod ends failing prematurely due to boot failure

- The boot fails and allows contaminants inside, resulting in corrosion and wear and causing excessive deflection in the socket assembly, loose steering and alignment toe angle changes.
- The failure of the boot is due to its material, which is made of polychloroprene with carbon black, typically used as strengthening filler. In this case, the amount of carbon black is reduced to achieve a blue-colored boot, but this compromises the strength of the material. (This is clearly evident in the illustration).

SILVERADO 2500HD 2WD
17613 Miles
OE Outer Dust Boot
