BULLETIN: 25877

Upper Ball Joint Premature Wear

1984-2004

General Motors S-10/15 (T) Series Light Trucks And SUVs

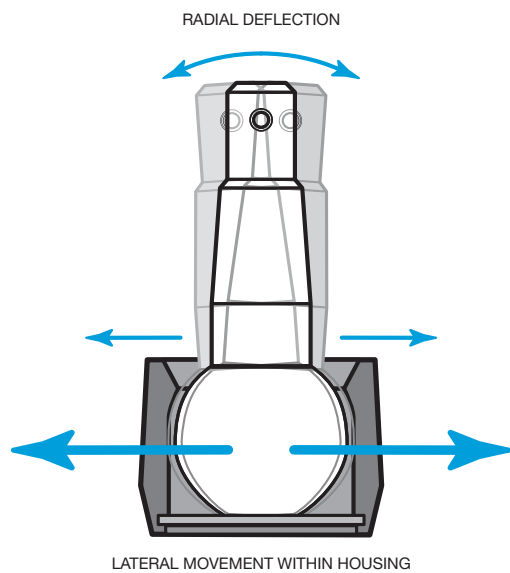
OE Upper Ball Joint Premature Wear

- Today's SUVs and light trucks are equipped with large wheel and tire assemblies that result in tall ride heights. This raises the vehicle's center of gravity, and the combination creates high lateral loads in turns. The high loads are transferred into the ball joints, causing radial deflection (sideways "play" or movement) that, in turn, creates stress and wear on bearing surfaces.
