BULLETIN: 25873

Excessive Play; Joint Separation

1997-1999

Dodge Dakota and Durango

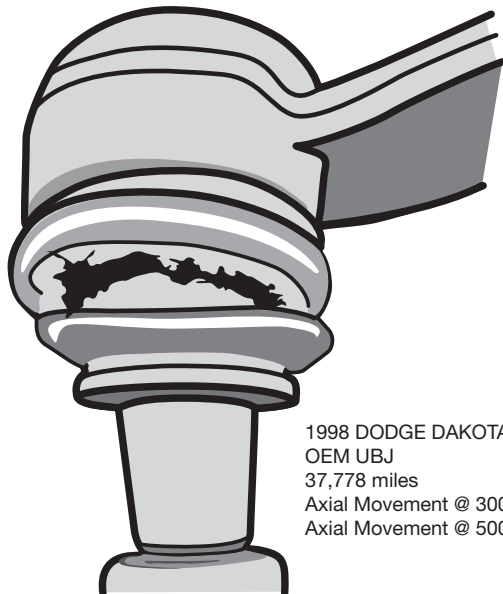
OE Ball Joint Fails Prematurely

- OE ball joints experience boot failure, letting contaminants in and allowing vital lubrication loss.
- Non-serviceable polymer socket design is unable to flush contamination; corrosion and wear quickly set in. (Failed OE Ball Joint problem illustration)

1998 DODGE DAKOTA 4WD
OEM UBJ
37,778 miles
Axial Movement @ 300 lbs = .045"
Axial Movement @ 500 lbs = .048"
