# Bulletin ServiceLink<sup>SM</sup>

Bulletin SL1-99

## SERVICE AND REPAIR OF 1986-96 TAURUS/SABLE FRONT STRUT ROD MOUNT

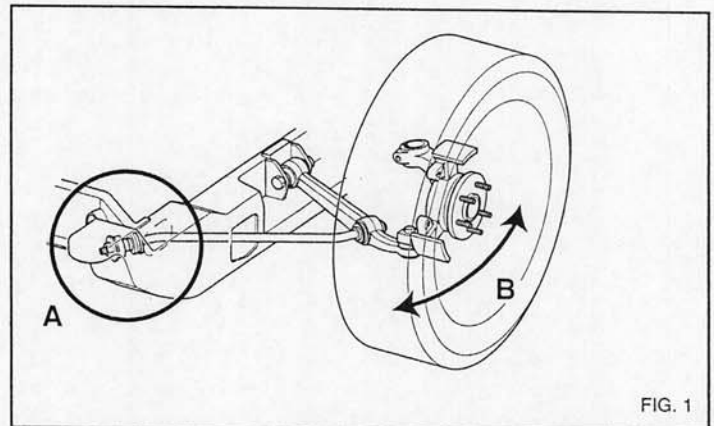
The front strut rod connecting point at the crossmember, on these vehicles, can deteriorate and allow excessive movement of the strut rod resulting in undesirable wheel movement. This movement of the rod (A) is magnified at the tire (B) and can cause sufficient alignment angle change to create a pulling problem during brake operation, figure 1. There can also be noise generated as the rod moves within the crossmember. This noise is usually a popping sound.

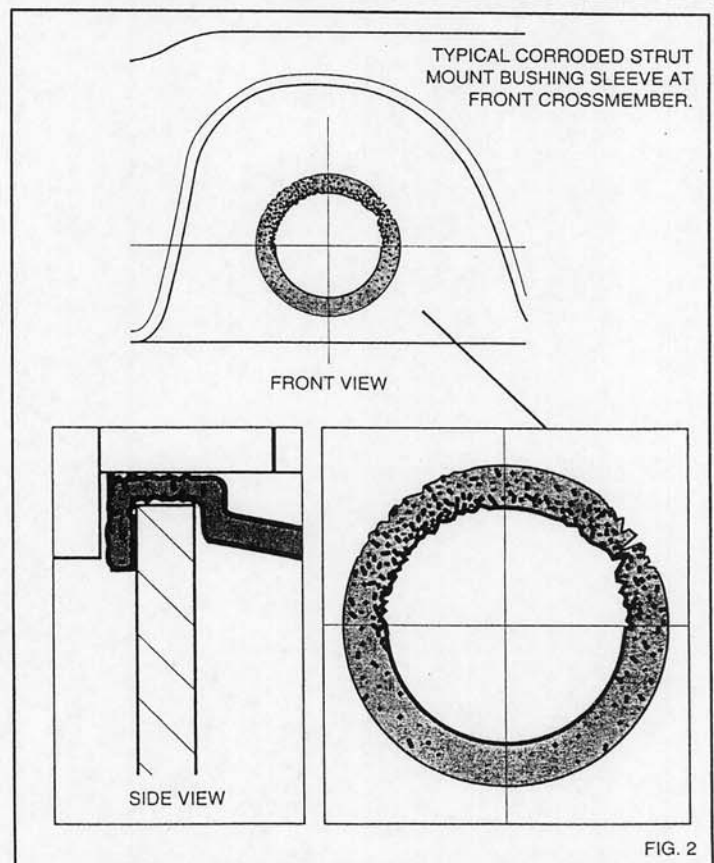
The wear probably is occurring in the strut rod bushing mounting sleeve. This sleeve is a stamped metal insert. As the insert corrodes it allows the rod and bushing to move within the crossmember, figure 2. This usually can be determined by careful visual examination of the crossmember at the bushing contact point.

Excessive movement of the strut rod will polish the frame area adjacent to the bushing. Also, as the stamped metal insert corrodes it can create a gap between the bushing and crossmember. This gap will usually allow you to see the condition of a portion of the insert without further disassembly.

To perform a more thorough inspection, disconnect and remove the strut rod from the lower control arm and crossmember. The condition of the mounting sleeve pilot hole must also be determined before continuing with the installation. If the pilot hole is excessively worn, another method of repair must be used.
