# TechPro<sup>SM</sup> Bulletin

BULLETIN CQ3-96

## FRONT STABILIZER BAR LINK 1986-94 TAURUS/SABLE, 1988-94 LINCOLN CONTINENTAL

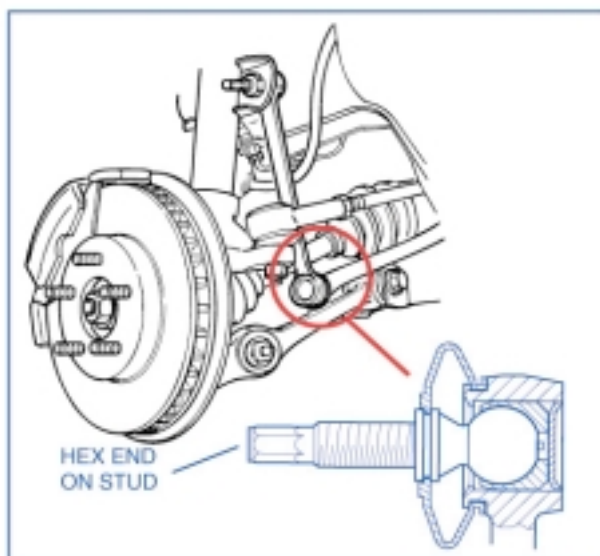
The appearance of the stabilizer bar link used on these vehicles can vary depending on the production year and previous service. The first OEM design utilized a metal link which incorporated a ball stud at each end. The ball studs are encapsulated in a plastic bearing. The second OEM design link is constructed from plastic. The appearance is visually different, but the the function and operating dimensions are the same as the first design. The CARQUEST, K8639, link is visually different from both OEM designs. The CARQUEST design is metal with the ball stud encapsulated in a plastic bearing. The CARQUEST ball stud design is similar to the OEM designs because it is a sealed unit protected by a rubber boot. Although physically different, all three designs have equivalent strength, serve the same function, and are interchangeable.

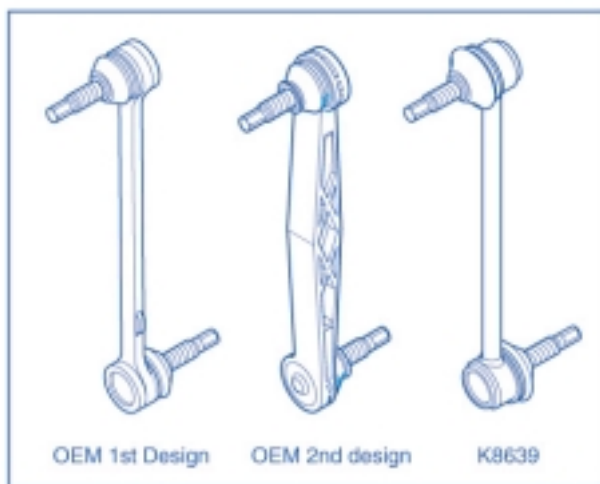
**NOTE:** Failure of the stabilizer link is often traced to improper service procedures.

The link is often disconnected to service the vehicle suspension or drive line. If an air wrench is used to separate the link from its attaching points failure in the ball stud/socket may occur. This is a result of using an air wrench and spinning the nut, while failing to hold the stud, to disconnect the link. The rapid spinning of the ball stud within the bearing can cause premature failure. The hex on the ball stud is to allow the technician to keep the stud from turning while removing the nut. Proper removal and installation will improve service life of the component.
