Bulletin SL11-95

STEERING GEAR FAILURE DUE TO IMPROPER TIE ROD INSTALLATION

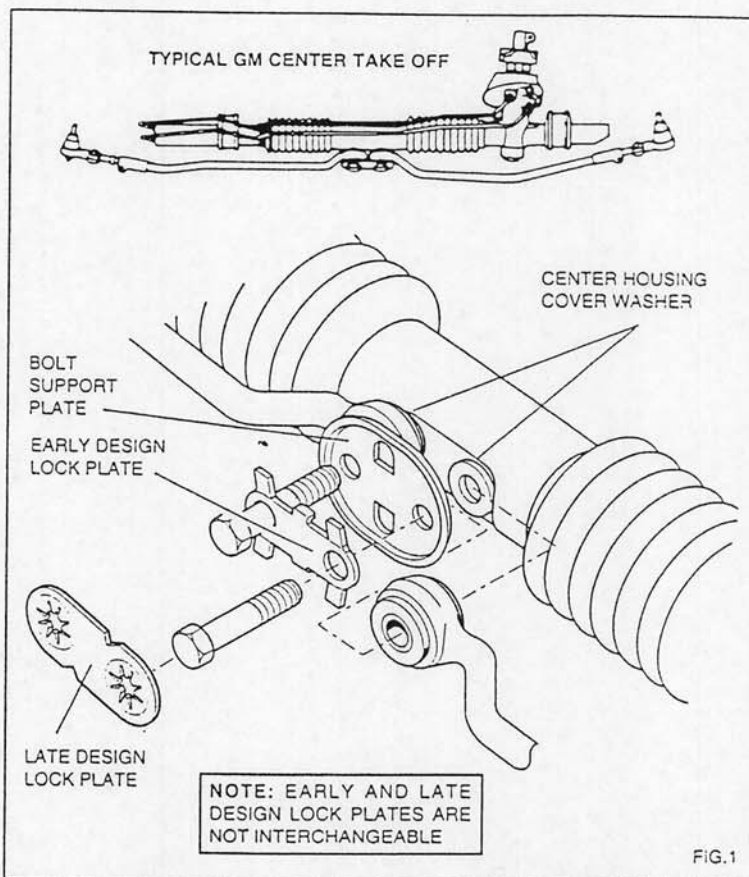
FIG. 1

If the center housing cover washer is omitted, the inner tie rod bolt may protrude through the steering rack and contact the housing (fig. 2). The bolt will grate against the housing inner wall and eventually cause the housing to break. Also, if the early gear design **lock plate** (fig. 1) is omitted, it too may allow the inner tie rod bolt to protrude through the steering rack. The early design lock plate must not be substituted with the late design lock plate.

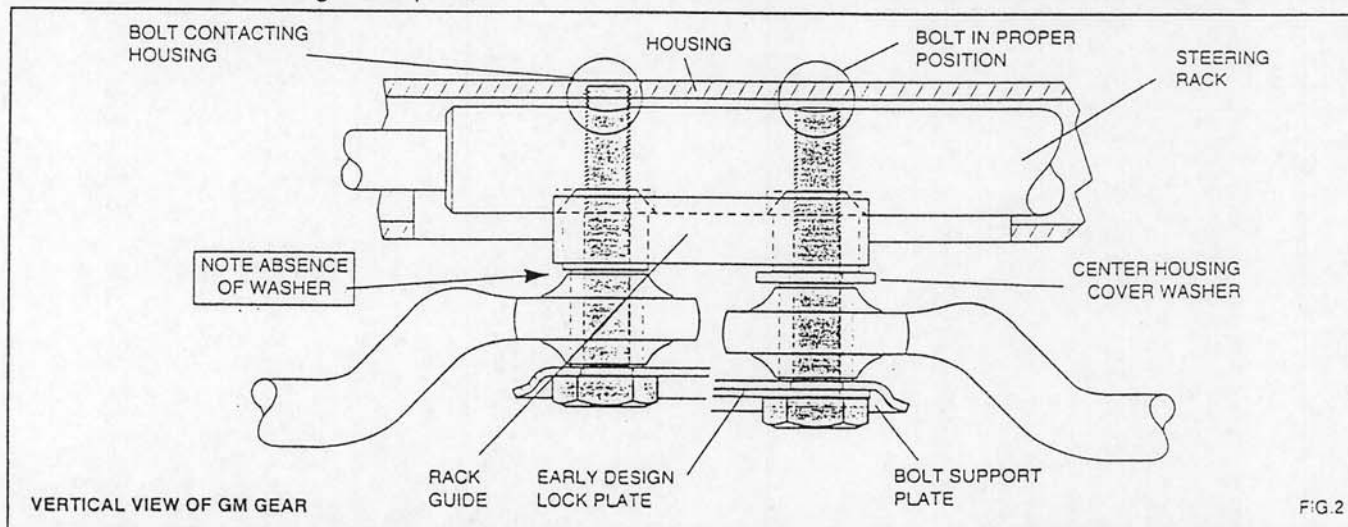
FIG. 2

Damage can result from components being omitted during reassembly. When the inner tie rod is connected to the gear, the **center housing cover washer** (fig. 2) must be between the inner tie rod and the rack guide.
