# Bulletin ServiceLink<sup>SM</sup>

Bulletin SL2-95  
© 1995 Moog Automotive Inc.

## SERVICE PRECAUTION FRONT STABILIZER BAR LINK 1986-94 Taurus/Sable, 1988-94 Lincoln Continental

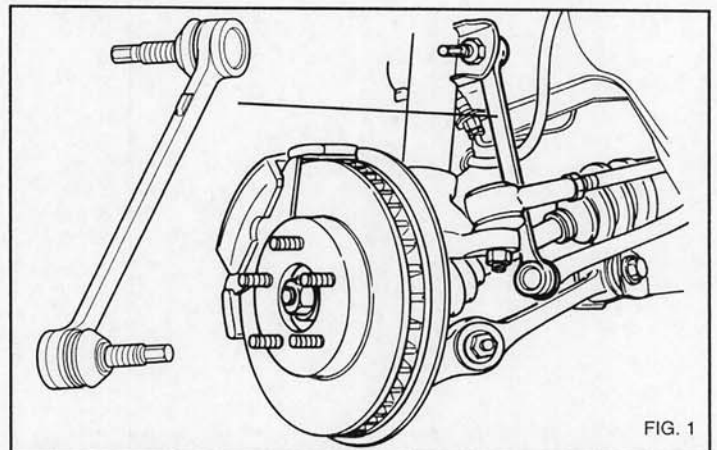
FIG. 1

The stabilizer bar link uses a ball stud and socket at each end. The studs, which allow the link to pivot, are encapsulated in a plastic bearing (non-greaseable and non-serviceable), fig.1.

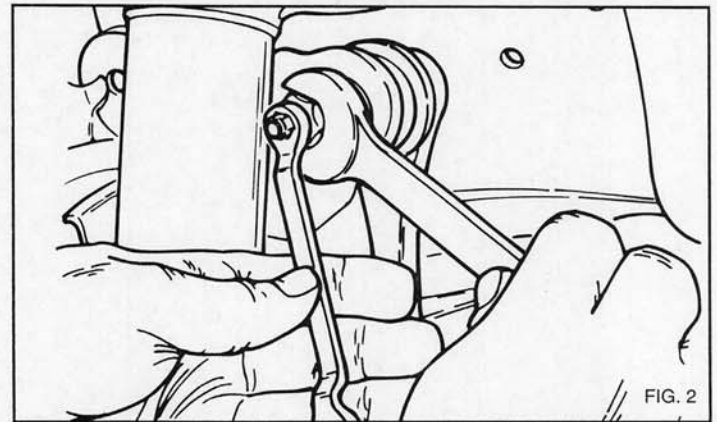
FIG. 2

The ball stud has an 8mm hex at the stud end to enable the technician to hold the ball stud stationary while removing the deformed thread nut (18mm), fig.2.

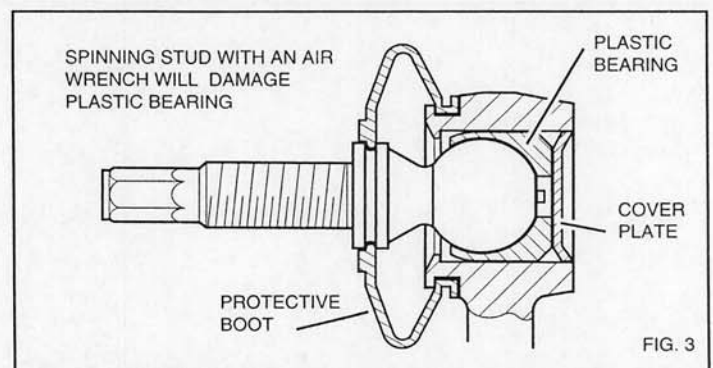
FIG. 3

The use of an air powered wrench to remove the nut by spinning the nut and ball stud can result in internal damage to the ball stud and plastic bearing. Damage to one, or both ends of the link can result in a rattle or a popping noise during suspension movement, fig.3.

Damaged or worn stabilizer bar links should be replaced. **K8639** link fits 1986-94 Ford Taurus, Mercury Sable, and 1988-94 Lincoln Continental.
