Bulletin SL5-94
© 1994 Moog Automotive Inc.

POSSIBLE UPPER BALL JOINT FAILURE 1988-94 CHEVROLET & GMC 4X4's

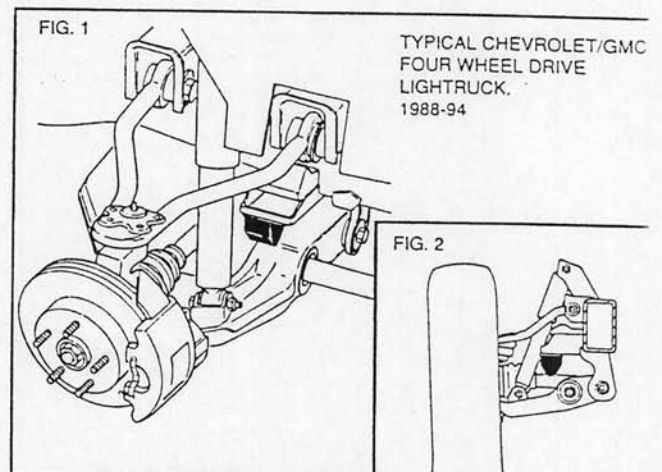
The upper ball joint is a follower ball joint mounted to a bar type control arm, fig. 1. The inspection standard is to look for perceptible looseness with the vehicle properly supported. Whether or not looseness is found on these suspensions further checks should be made to see if there were any contributing causes for failure other than normal wear. If there is suspension damage as described below, it may cause a problem in the future.

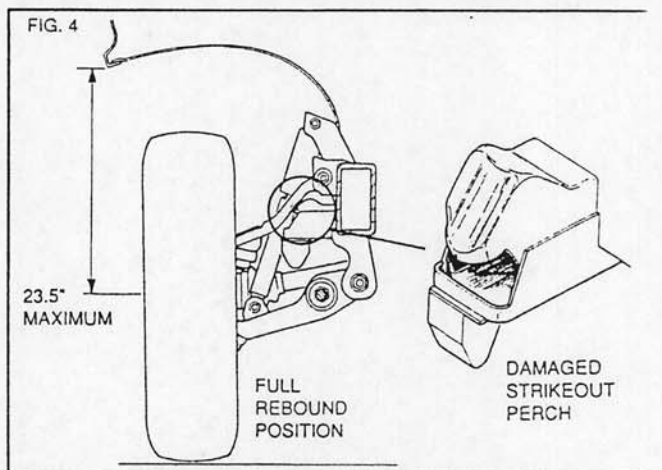
The suspension limiting device in the rebound direction is the shock absorber. If a longer shock absorber is installed, the bar type arm may introduce undue force on the strikeout perch and damage may result. If the strikeout perch or shock absorber are damaged in any way, or if the shock absorber allows more suspension travel than the original equipment shock, they must be restored to their original operating condition.

If a strikeout perch shows evidence of sustained contact or damage, fig 4, further investigation is required.

- Check the shock absorber for damage and for correct extended length. If the extended length is more than 16.5", the shock absorber must be replaced with a unit that meets OEM specifications.
- Measure as shown in fig. 4. With the suspension in full rebound, a vehicle with an OEM shock absorber and strikeout perch in good condition will measure 23.5" maximum from the center of the wheel to the underside of the fenderwell.
- Check that the vehicle curb height is correct.
- Check for damage to upper control arm. Note: If the above factors are not inspected or corrected, ball joint failure could result.
