Bulletin SL8-96

POPPING NOISE FROM FRONT STRUT ROD BUSHING

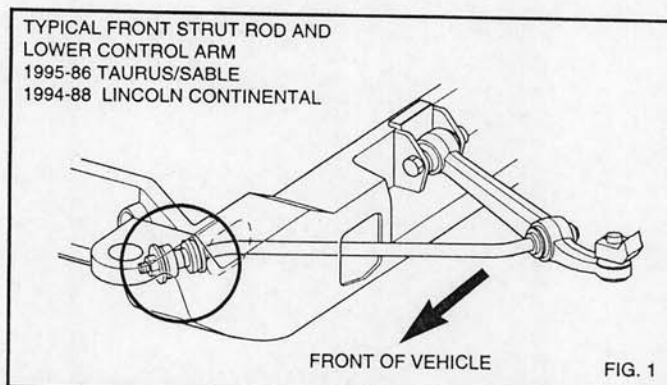
Some 1995 through 1986 Ford Taurus/Mercury Sable and 1994 through 1988 Lincoln Continentals will exhibit a popping noise during braking and cornering. This can be the result of the front strut rod bushing mounting receptacle (receiver), in the front cross-brace, moving within the frame, figure 1.

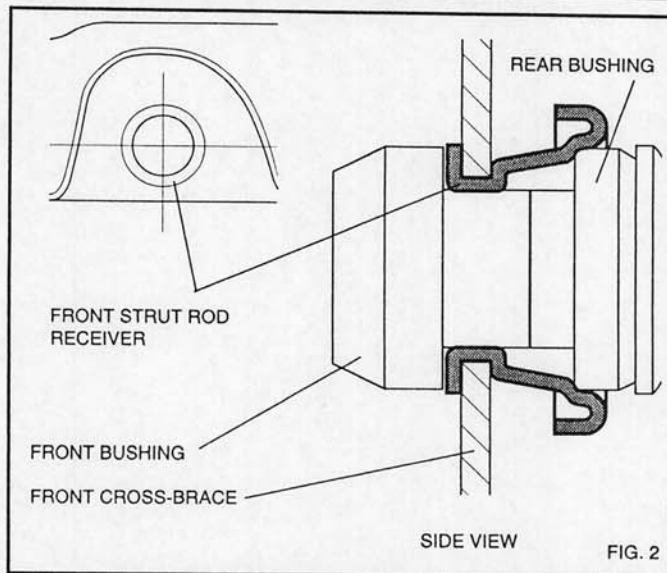
To determine if there is a problem examine the area where the strut rod connects to the front cross-brace, figure 2. Look for indications of movement. It may be necessary to disconnect the strut rod to get a better indication of the condition of the receiver/receptacle.
