Bulletin SL 9-91
© 1991 Moog Automotive, Inc.

4 X 4 BALL JOINT INSTALLATION

IMPROPER INSTALLATION CAN CAUSE STEERING PROBLEMS AND PREMATURE BALL JOINT FAILURE

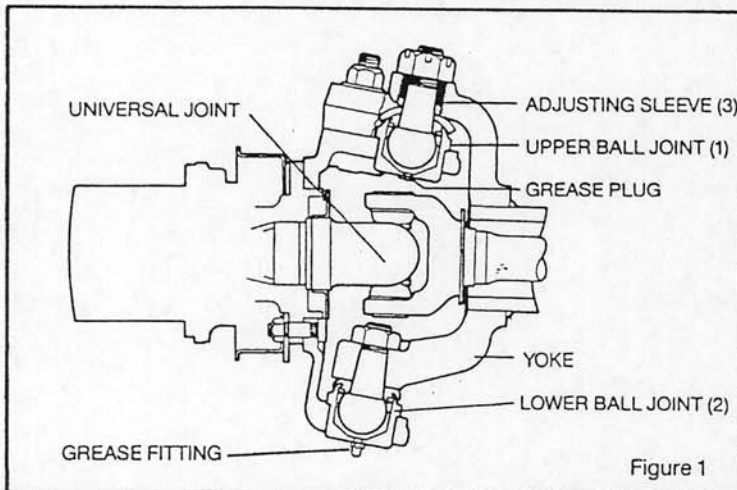
On this type axle, upper (1) and lower (2) ball joints are load carriers. To ensure that the load is properly distributed an adjustment sleeve (3) is used, in conjunction with the upper ball joint. (Fig. 1)

TORQUE SEQUENCE	TORQUE
1. Lower Ball Joint	70 Foot Pounds
2. Adjusting Sleeve	70 Foot Pounds
3. Upper Ball Joint	100 Foot Pounds

NOTE: Clean threads before installing new sleeve. Threads must be clean or torque accuracy will be affected.

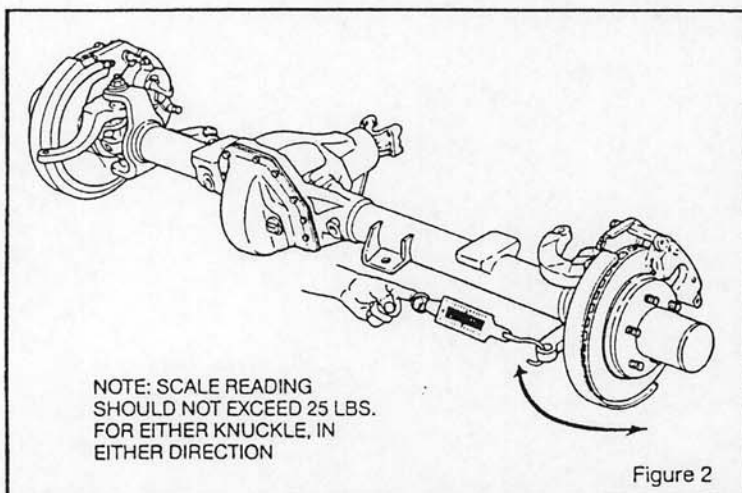
Improper tightening or backing off the adjustment sleeve can cause tight steering which can cause steering wander. Improper loading of ball joints can also occur, causing premature ball joint failure.

After ball joint installation, check steering effort with a pullscale. If reading is high, above 25 lbs, break tapers, and disassemble. Check ball joints for looseness. If not loose reassemble and torque to specification. (Fig. 2)

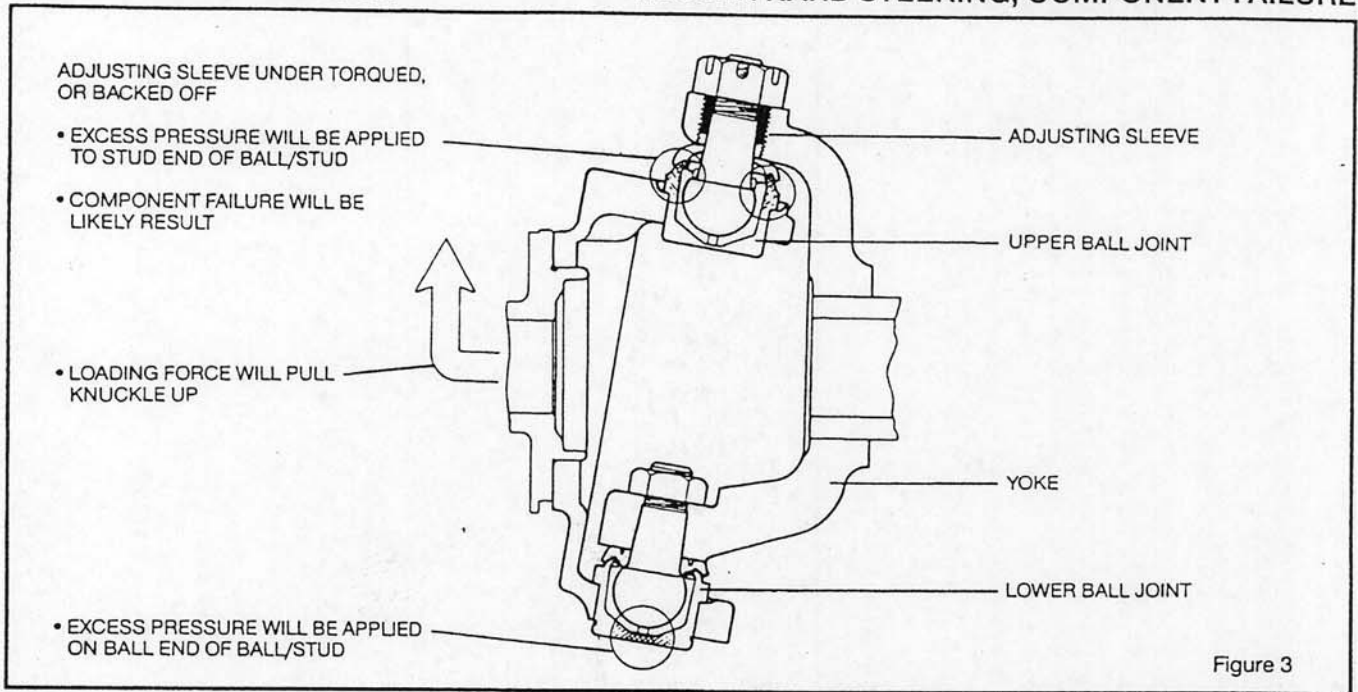
IMPROPER INSTALLATION

RESULT: HARD STEERING, COMPONENT FAILURE

The improper installation shown above or hard steering complaints can be minimized by checking spindle tightness as shown in Fig 2.
