# TECHNICAL SERVICE BULLETIN

1984-2000 Chrysler, Dodge & Plymouth Vehicles with Adjustable Motor Mounts

Inner C.V. Joint "Pull Apart" or Vibration

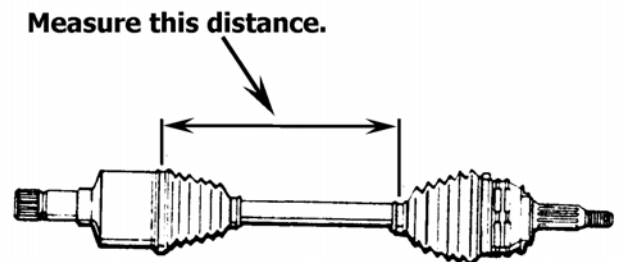
- A. If both axles are the same length and style, this method can be used. With the vehicle on the ground or on a drive-on type hoist measure the distance from the small clamp on the outer joint to the large clamp on the inner joint (always take measurements from the bottom of the axle). Do this on both axles, compare the measurements, and adjust the motor accordingly.

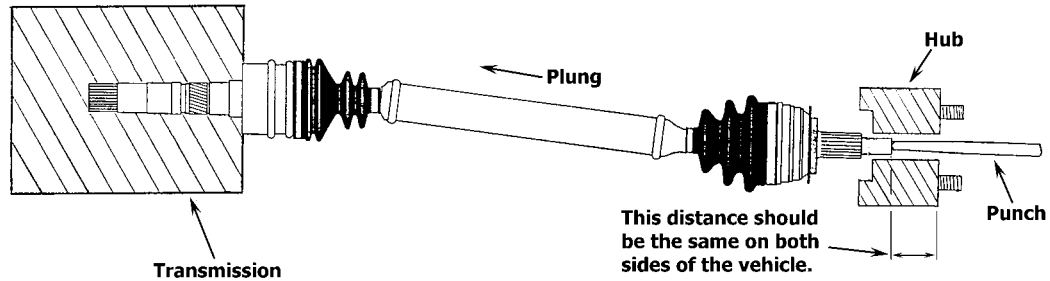
- B. With the vehicle on the ground or on a drive-on type hoist, remove the nuts from both axles. Push the axle towards the transmission and bottom out the inner joint. Using a punch or a small bar, measure the distance the stub shaft has withdrawn into the hub. Mark the bar or punch at the edge of the hub. Do this to both axles and compare the measurements. If the measurements are not the same, the engine and transmission need to be adjusted.

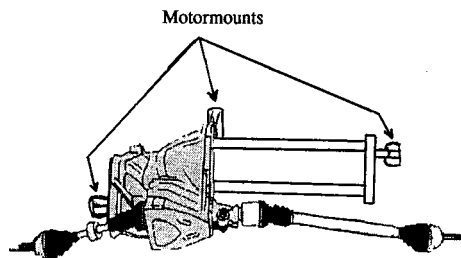
- C. With the vehicle on the ground or on a drive-on type hoist, remove the large clamp from the inner joint of both axles. Pull the boot back and look at where the tripod is riding in the housing. The tripod should ride in the middle of the housing. It should not be riding on the edge or at the bottom of the housing. Do this to both sides, compare the two, and adjust the motor accordingly.

1. Carefully support the motor and transaxle with a floor jack.
2. Loosen right motor mount fasteners, front motor mount bracket, and front crossmember fasteners.
3. Pry motor left or right as needed and tighten all fasteners.
