TECHNICAL SERVICE BULLETIN

NO. 2001

1988-97 Chevrolet & GMC 4WD Trucks

Cracked or broken housing on inner C.V. joint.

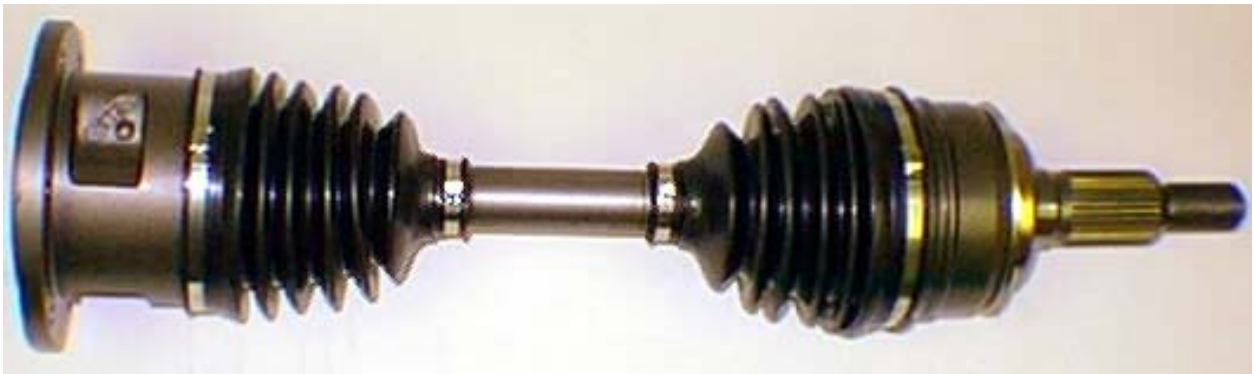
Many of the cores that we are receiving have cracked or broken housings on the inner C.V. joint. The cause of this problem is due to the angle of the axles in the vehicle. At O.E. ride height the axle deflection is not steep. If the torsion bars are adjusted to the max ride height to accommodate larger tires the axles are forced to run at a much steeper angle. If you increase the angle that an axle runs at you also increase the length of the axle. This forces the inner tripod bearings to ride out on the edge of the inner housing and eventually crack or break the housing. This problem is also caused by some of the lift kits on the market. These lift kits raise the front differential along with the rest of the truck causing the axle to run at a much steeper angle. A good lift kit will include a bracket that lowers the front differential and keeps the axles at the O.E. angle.

Use a lift kit that includes the drop down bracket for the front differential or lower the torsion bar adjustment to O.E. Ride height.
