# TECHNICAL SERVICE BULLETIN

NO. 2002

1989-95 Mazda MPV 4X4

Front Inner Joint Vibration

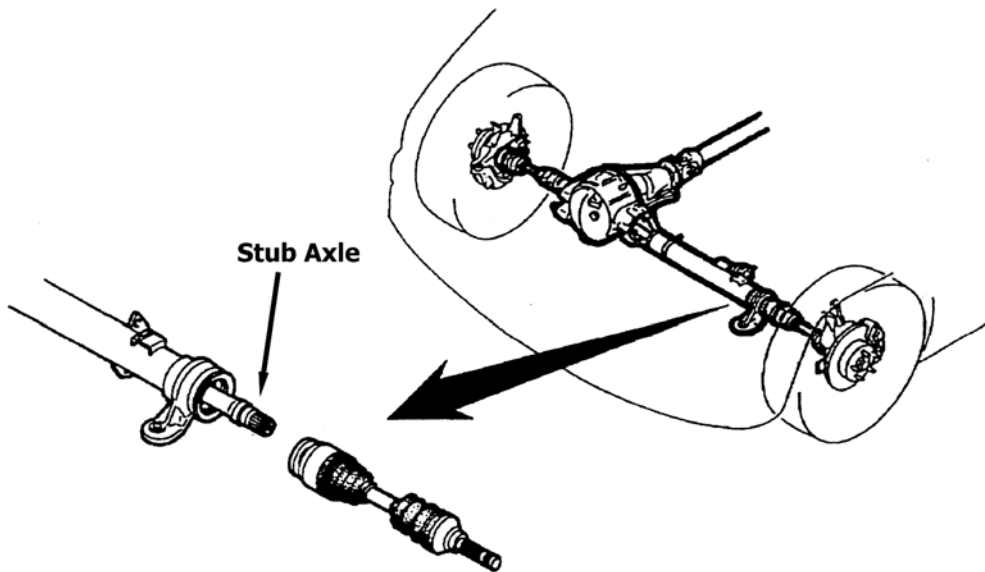
The splines on the stub shaft on the driver's side of the vehicle wear and create a loose connection for the inner joint. The inner joint housing will move on the stub and cause a vibration.

These splines must be lubricated with molybdenum grease. Apply 3-4 grams of molybdenum grease to the stub shaft splines prior to installation. If a vibration still persists then it may be necessary to replace the stub shaft.
