TECHNICAL SERVICE BULLETIN

NO. 2005

SUBJECT

Vehicles with the Ford CD4E automatic transmission.

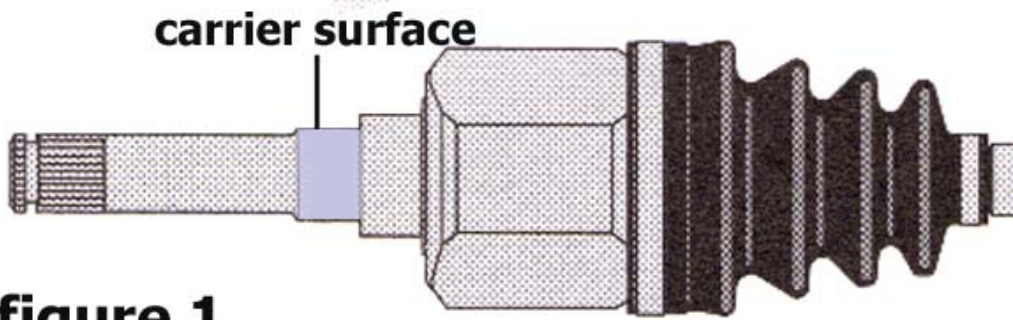
figure 1

The driver's side front CV axle has a 6-1/2 inch male inboard stub that fits into the transmission's side gear. On the stub next to the housing seal surface is a carrier support surface that fits into the final drive sun gear inside the transmission (see figure 1). This sprocket assembly is chain driven with the reverse/overdrive sprocket by the planetary gear sets (see figure 2). The final drive sprocket assembly rides on the axle stub carrier support surface using a pressed, center bored bushing. This bushing wears the carrier support surface causing damage to the axle and eventually the transmission.

If the carrier support surface of the axle being replaced appears rough and worn, then several possible failures need to be checked before replacing the axle or premature failure of the axle or possible damage to the transmission could occur. If the transmission's internal oiling solenoid that lubricates this bushing fails, then the 2nd and 3rd gearshifts will not function. Although the Aftermarket lists this bushing, no tool exists to replace it. Ford only offer the bushing in a complete sprocket assembly making its replacement a very costly repair.
