PROBLEM Solver™ BULLETIN

THE PROBLEM: CORRODED TIE ROD ADJUSTING STUDS

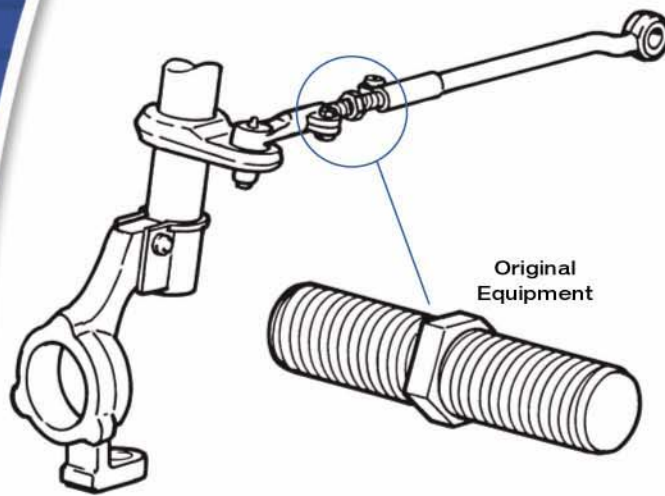
- The corroded tie rod adjusting studs may prevent proper toe setting and straight steering wheel during alignment.
- Excessive corrosion is common to 2-year and older vehicles.
- Corroded threads will make adjustments difficult or impossible.

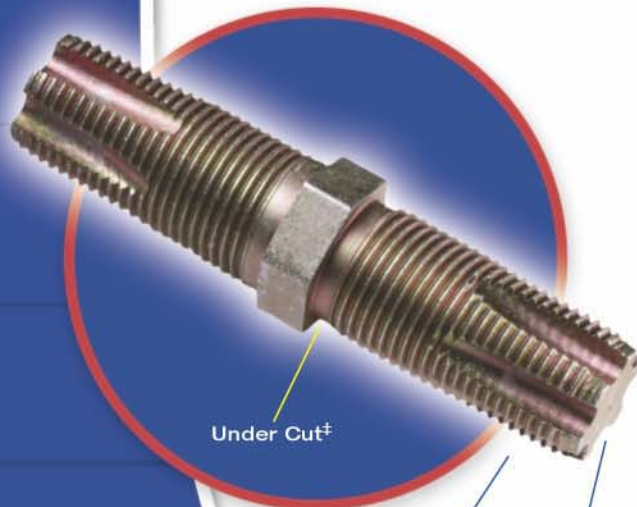
Corrosion Build-Up

Inspect Threads

- Under Cut[†] indicates that this end threads into inner tie rod (left hand threads).
- Complete cleaning of tie rod cavity may be required if corrosion build-up is severe. Use M18x1.5 tap to clean threads.
- Inspect tie rods thoroughly and replace, if necessary.
- Thread engagement of adjuster stud into inner and outer tie rod must be equal.
- Use thread lubricant to ease installation.
