TECHNICAL SERVICE BULLETIN

NO. 2000

1984-2000 Chrysler, Dodge & Plymouth Vehicles with Adjustable Motor Mounts

Inner C.V. Joint "Pull Apart" or Vibration

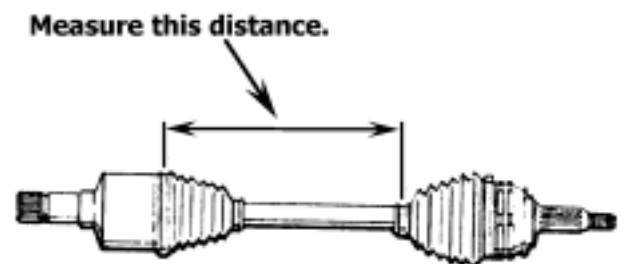
- A. If both axles are the same length and style, this method can be used. With the vehicle on the ground or on a drive-on type hoist measure the distance from the small clamp on the outer joint to the large clamp on the inner joint (always take measurements from the bottom of the axle). Do this on both axles, compare the measurements, and adjust the motor accordingly.

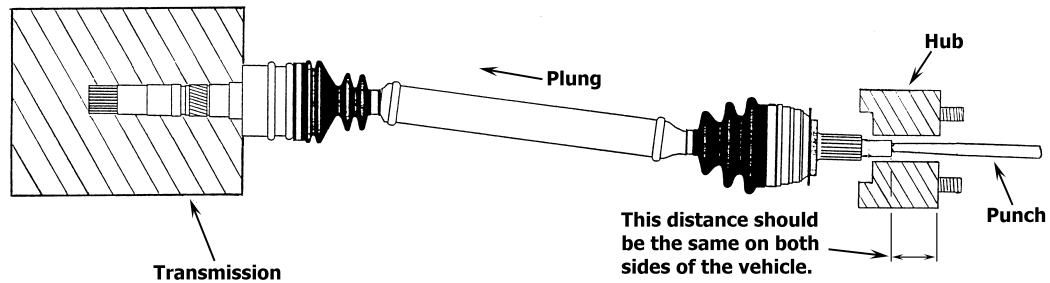
- B. With the vehicle on the ground or on a drive-on type hoist, remove the nuts from both axles. Push the axle towards the transmission and bottom out the inner joint. Using a punch or a small bar, measure the distance the stub shaft has withdrawn into the hub. Mark the bar or punch at the edge of the hub. Do this to both axles and compare the measurements. If the measurements are not the same, the engine and transmission need to be adjusted.

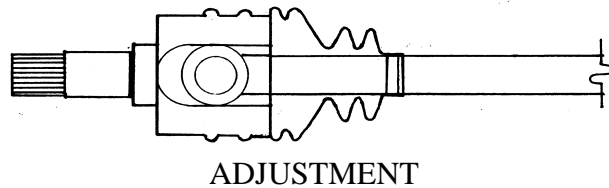
- C. With the vehicle on the ground or on a drive-on type hoist, remove the large clamp from the inner joint of both axles. Pull the boot back and look at where the tripod is riding in the housing. The tripod should ride in the middle of the housing. It should not be riding on the edge or at the bottom of the housing. Do this to both sides, compare the two, and adjust the motor accordingly.
