TECHNICAL SERVICE BULLETIN

NO. 2002

1989-95 Mazda MPV 4X4

Front Inner Joint Vibration

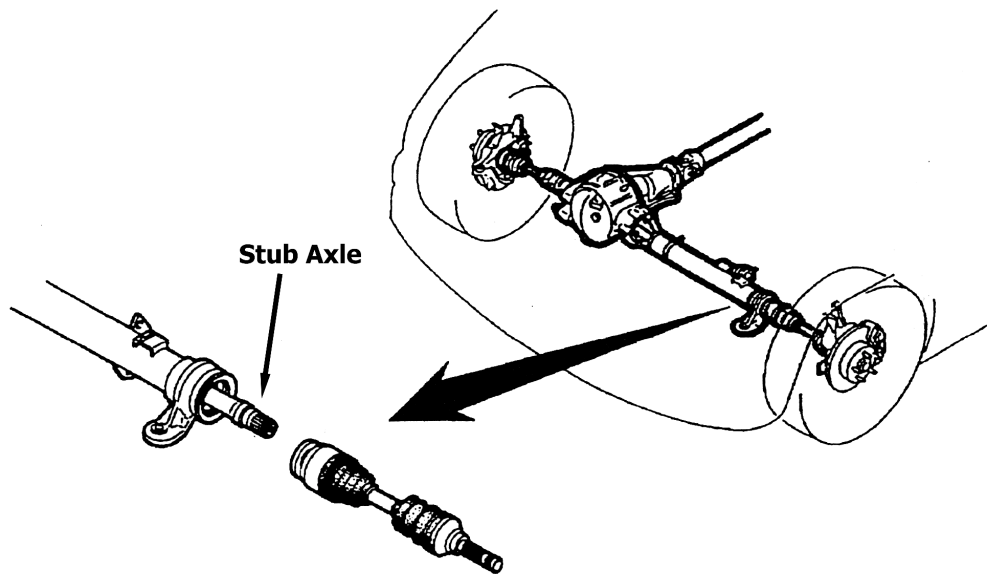
The splines on the stub shaft on the driver's side of the vehicle wear and create a loose connection for the inner joint. The inner joint housing will move on the stub and cause a vibration.

These splines must be lubricated with molybdenum grease. Apply 3-4 grams of molybdenum grease to the stub shaft splines prior to installation. If a vibration still persists then it may be necessary to replace the stub shaft.
