# TECHNICAL SERVICE BULLETIN

NO. 2005

Vehicles with the Ford CD4E automatic transmission.

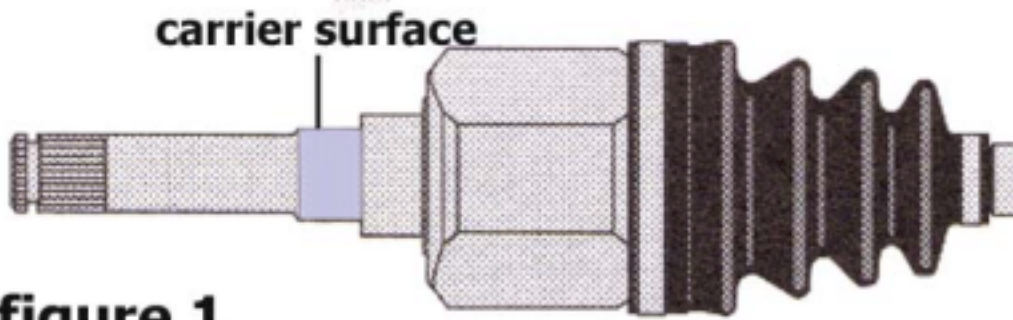
**figure 1**

The driver's side front CV axle has a 6-1/2 inch male inboard stub that fits into the transmission's side gear. On the stub next to the housing seal surface is a carrier support surface that fits into the final drive sun gear inside the transmission (see figure 1). This sprocket assembly is chain driven with the reverse/overdrive sprocket by the planetary gear sets (see figure 2). The final drive sprocket assembly rides on the axle stub carrier support surface using a pressed, center bored bushing. This bushing wears the carrier support surface causing damage to the axle and eventually the transmission.

If the carrier support surface of the axle being replaced appears rough and worn, then several possible failures need to be checked before replacing the axle or premature failure of the axle or possible damage to the transmission could occur. If the transmission's internal oiling solenoid that lubricates this bushing fails, then the 2<sup>nd</sup> and 3<sup>rd</sup> gearshifts will not function. Although the Aftermarket lists this bushing, no tool exists to replace it. Ford only offer the bushing in a complete sprocket assembly making its replacement a very costly repair.

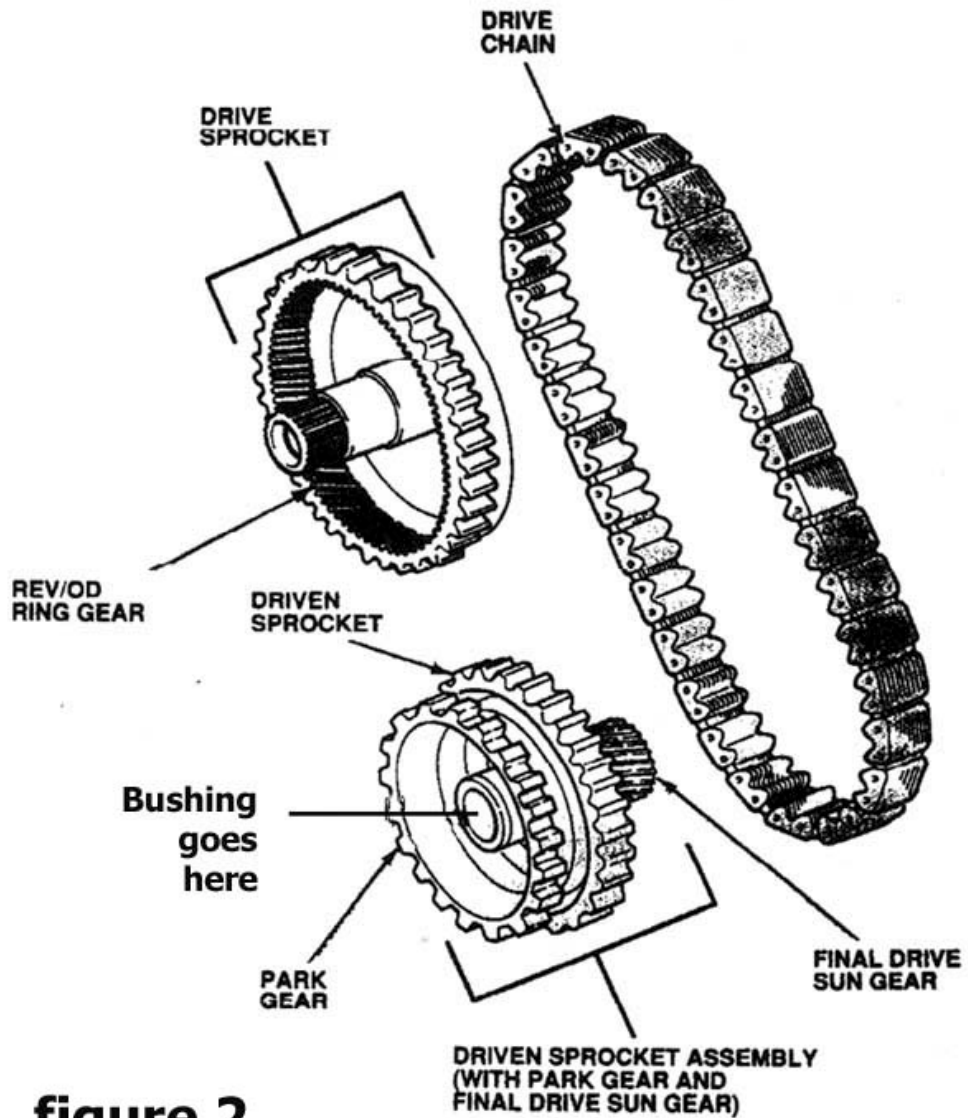
**figure 2**

The most common contributor to premature wear of this bushing is the vehicle not being within proper alignment specs. Without a four-wheel alignment, even though the front wheels may be centered to the rack, the rear thrust is pushing the front wheels causing stress on the front CV joints. The thrust forces acting on the front wheels while driving changes ALL the alignment specs resulting in the front wheels being in a constant turning action. This will wear the side gears and transmission seals as well as stressing this bushing. Another possible sign that alignment is affecting these items is a worn or torn inboard boot. Do not forget that worn motor mounts will also affect alignment thrust forces.
