TechPro

# Bulletin

## GM'S EV FAN SYSTEM GM VEHICLES - 2000 & LATER

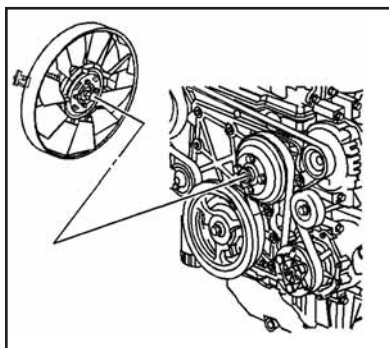
energize it. By varying the on time of the pulses, the PCM can control fan speed. The relay contacts send power to the fan clutch. A solenoid in the clutch allows fluid past spring loaded valves to "lock up" the clutch when energized, causing fan speed to increase. By varying the on time fan speed is controlled. The PCM monitors fan speed by a three wire Hall effect sensor, which pulses a voltage back on the signal line. Both the command and the feedback can be seen on a scan tool to see if the system is in control.

From the calls we've seen so far, the most common issues seem to be P0495 or P1484. The callbacks with fixes mostly were bad fan clutches. Some of the earlier vehicles had updated flash calibrations to make the P1484 less likely to set. When diagnosing one of these that seem to operate ok, don't forget to check for updates!

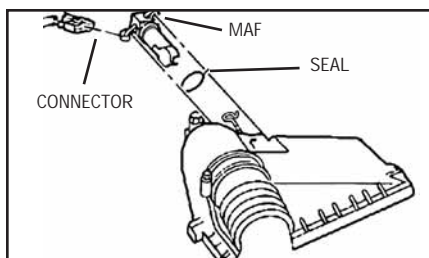
Chevy's '98-'02 Prizm, with it's Toyota systems, has been a very trouble free vehicle. Recently though we've been getting calls with a MIL on and a P0171 in memory. The owner may also mention a slight hesitation or not as much power lately. Both concerns we've mentioned could stem from a lean condition where fuel pressure and O2 sensor testing show those

systems ok. It may be time to look at the MAF sensor. These cars use a 5-wire unit located in the air filter housing. The sensor uses the hot wire method to sense airflow and integrates the intake air temperature sensor.

The MAF's job is to be the primary sensor for engine load so the PCM can calculate fuel and timing requirements. You can watch the sensor input on a scan tool as grams/sec. This value changes with RPM and engine load. If the sensor is skewed low, it won't "tell" the PCM about all of the air passing through it and the PCM won't calculate a long enough on time for the injectors. For example, when the throttle is first opened on acceleration, a shifted sensor may "miss" the extra rush of air coming into the engine and cause a lean stumble. Another possibility would be if the sensor didn't report all the air entering at high speed cruise resulting in a slightly short on time and the fuel trims going up to try and compensate from that end.
