TechPro

Bulletin

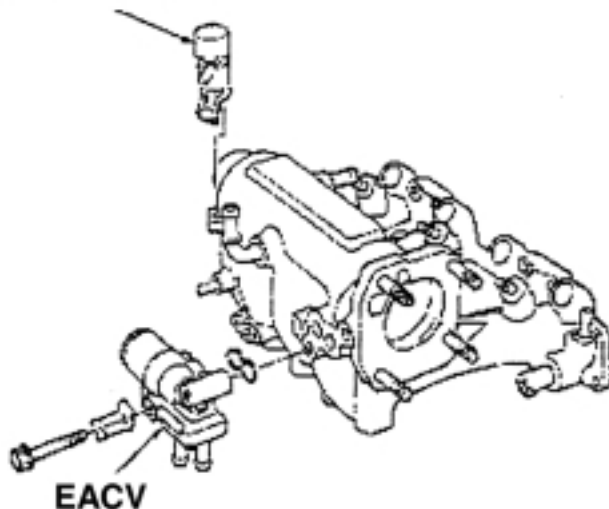
DIAGRAM # 1

Major engine work can be a long and tedious job without having subsequent driveability problems after you're done. But if you experience idle problems after doing major engine work, here's a tip that can save you a lot of diagnostic time. If the vehicle exhibits a surging idle after it warms up, check for code # 14, which is for the electronic air control valve solenoid (EACV). If you have this code, you may have crossed the connectors for the EACV with the Purge Control solenoid valve. These two connectors are identical in shape as well as being very close together in the engine compartment. The best way to identify the connectors is by using the wire colors to differentiate them. Both connectors have a yellow wire with a black stripe, which is the power feed wire. The EACV has a blue wire with a yellow stripe,

while the Purge Control has a red

wire. A simple repositioning of these connectors should alleviate the idle problem. (Refer to diagram # 1).

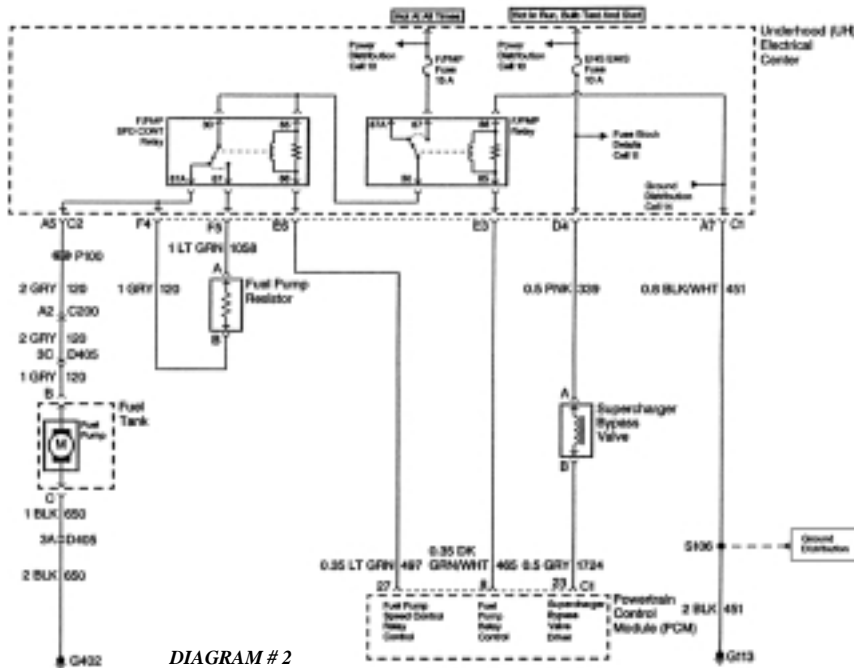
DIAGRAM # 2

You may run across one of these vehicles that exhibits a start and stall symptom. During diagnostics, you notice that it starts OK, but it dies out after a few seconds of running. Fuel pressure at Key on, engine off, is up to spec. (48-55 psi.). However, once the car is started, the pressure drops gradually until it stalls. On this system the fuel pump can be run at two speeds, depending on fuel demand. At idle and light load conditions, the pump is run at a reduced speed because the voltage to the pump is reduced. During cranking and high load conditions, the pump is running at full speed because it is receiving full battery voltage. This is accomplished through the use of two fuel pump relays and a dropping resistor in series with the fuel pump. The first relay is designated as the "fuel pump relay". This relay is controlled in the same manner as GM has been doing for years. It is turned on for two seconds at "key on", and it is turned on whenever the engine is cranking or running. The second relay is designated as the "fuel pump speed control relay". As its name implies, it is used to control the speed of the fuel pump.

The output of the "fuel pump relay" is

routed through the “fuel pump speed control relay”. When the speed control relay is energized by the ECM, power to the fuel pump is sent through a resistor, dropping the circuit voltage, resulting in reduced pump speed. When the ECM decides not to energize the speed control relay, the resistor is bypassed and the pump runs at full speed because it is receiving full battery voltage. (Refer to diagram #2) Failure of the resistor will create the symptom of a start and stall as we have described. This resistor is located on the outside of the frame rail, just ahead of the passenger side front wheel housing. It is a ceramic resistor that is similar to the ignition ballast resistors found on earlier cars. Its location causes it to be exposed to the elements, road debris, as well as any potential body damage. If the resistor is suspected as being a problem, it can be bypassed by jumping a test lead across the harness. If the vehicle now runs, the resistor needs to be replaced. This is also a good location to test fuel pump current draw. Just disconnect the resistor and connect the leads to your ammeter.

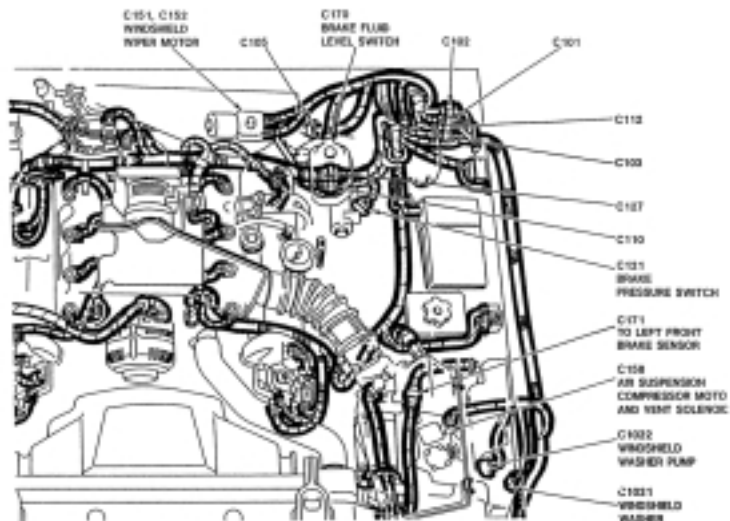
DIAGRAM # 3

ECM. All you have to do is jump the connector to get the fuel pump to run. If you jump the connector and the pump does not run, either you do not have power to the connector, or the inertia switch needs to be checked (see diagram # 5). If the vehicle does not have the connector, then you can jump the harness

these vehicles. The symptoms are usually the same: no fuel pressure, but it does have spark and injector pulse. It seems that the connector that supplies battery power from the power distribution box to the fuel pump has a tendency to collect moisture. When that happens, electrical problems will arise. The suspect connector is located in the driver’s side rear engine compartment (see diagram #3). It is black in color, and has 4 to 8 wires in it (see diagram #4). A quick way to determine if there is a problem with this connector is to bypass it. On some models, Ford makes this very easy by supplying a fuel pump test connector. This is a two wire connector which looks similar to the SPOUT connector. A quick way to identify it is by looking for one of the wires to be a dark green with a yellow stripe. This connector bypasses the relay, ignition switch, and the
