TechPro Bulletin

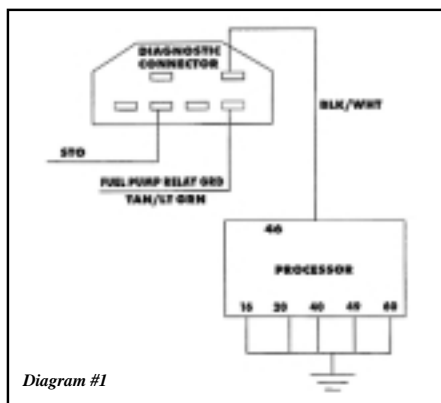
Diagram #1

The vehicle symptoms include: poor running, Check Engine light illuminated, and the scanner display becomes blank when it is connected. It's no secret that all power and ground circuit integrity is critical for a computer controlled vehicle to operate properly, and Fords are no exception. A large number of sensors (such as: the Throttle Position sensor, Manifold Absolute Pressure sensor, Coolant Temperature sensor, and the Manifold Air Temperature sensor) are grounded at pin # 46 of the ECM. Even one of the terminals of the diagnostic connector is grounded at pin # 46 (see diagram #1). This ground circuit is controlled through the ECM. The only time the ground is provided is when the ignition key is in the "On" position. When this ground circuit has a large enough voltage drop (that's over .050volts, or 50 millivolts), the voltage signals provided by certain sensors, which the ECM is using to control

fuel delivery and spark advance, will be incorrect, creating driveability problems and scanner communication problems. In addition to checking pin # 46 it's important to check the other grounds as well when diagnosing intermittent driveability problems. These grounds are also located at pin #'s: 16, 20, 40, 49, and 60.

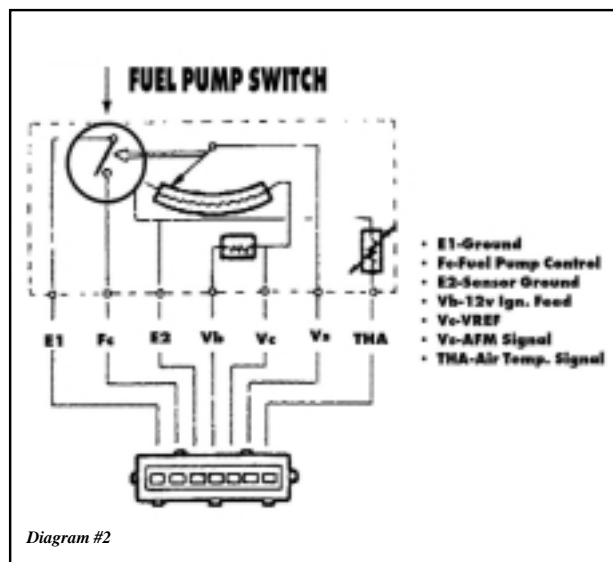
Diagram #2

The air flow sensor contains a switch which grounds the windings of the circuit opening relay (or fuel pump relay). If you unplug the airflow sensor and the pump stops running, you're on the right track (see diagram # 2). The only time the airflow sensor grounds the relay is when the sensor plate is open. If the fuel pump runs constantly when the key is on, and the engine is not running, then this indicates that the flap in the sensor is stuck open. Carefully inspect the sensor for binding. This would also explain the rich running condition. The air flow sensor, being out of position, is misleading the ECM into thinking that the engine is under load, which would cause the ECM to add fuel unnecessarily, resulting in an over rich condition. Outside of cleaning, no other repair is recommended other than replacement of the sensor.

If you come across a Toyota with a vane type airflow sensor and the customer is complaining of black smoke out of the tail pipe and poor fuel economy, check for a binding airflow sensor plate. A lead into solving this problem would be that the fuel pump is running constantly when the ignition key is in the "On" position.

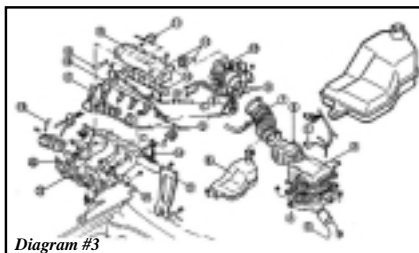
These symptoms are created as a result of a lean condition. Normally, air flows through the Air Flow meter, then through the Air Induction tube to the throttle body. If you examine the bottom of the air tube, you will see a short section of tube leading into a large plastic box called a Resonance Chamber (*see diagram # 3*). The purpose of this chamber is to dampen the pulses generated by the four cylinder

intake, so the Air Flow meter has a smooth signal. Old age usually takes its toll on plastics. Also, if the engine should backfire,

this chamber may rupture or crack. The size of the crack determines the severity of the driveability problem. What usually happens is that the Resonance Chamber splits along the seam, which makes it difficult to notice. Taping or using epoxy to repair the crack usually solves the problem temporarily. The only recommended fix is to replace it.

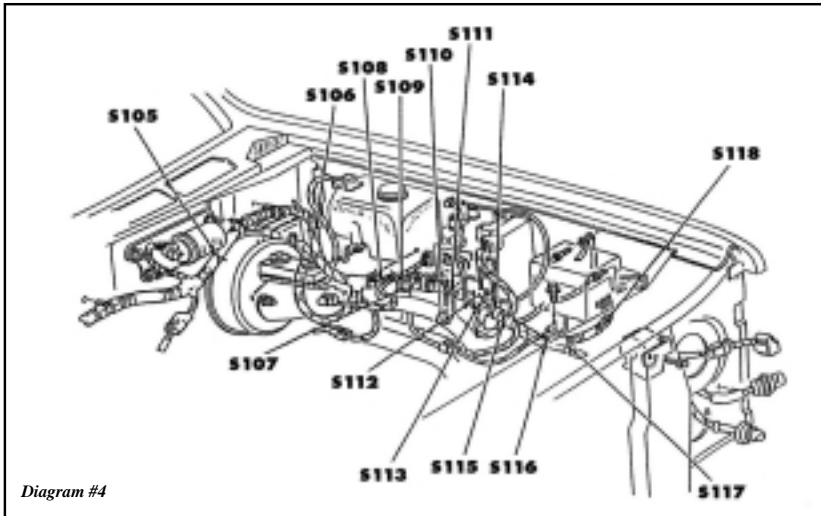
Diagram #4

The problem may be a no start, or an intermittent stall with a hard start. This symptom is caused due to no power to the ECM's memory circuit and to the ASD and fuel pump relays.

The power to the ASD and fuel pump relays are supplied by the 30 amp maxi fuse "D", which is located in the engine compartment power distribution center. Power to the ECM is then routed through a splice (*designated as "S115"-see diagram #4*), Which is located in the main computer harness which is on the driver's side inner fender well. Checking the integrity of this splice first could be a time saver. The plastic which covers this splice has a tendency to collect moisture, salt, etc.

which leads to corrosion of this splice, cutting power to the ECM. This splice is a problem which needs to be repaired and protected to prevent another failure.

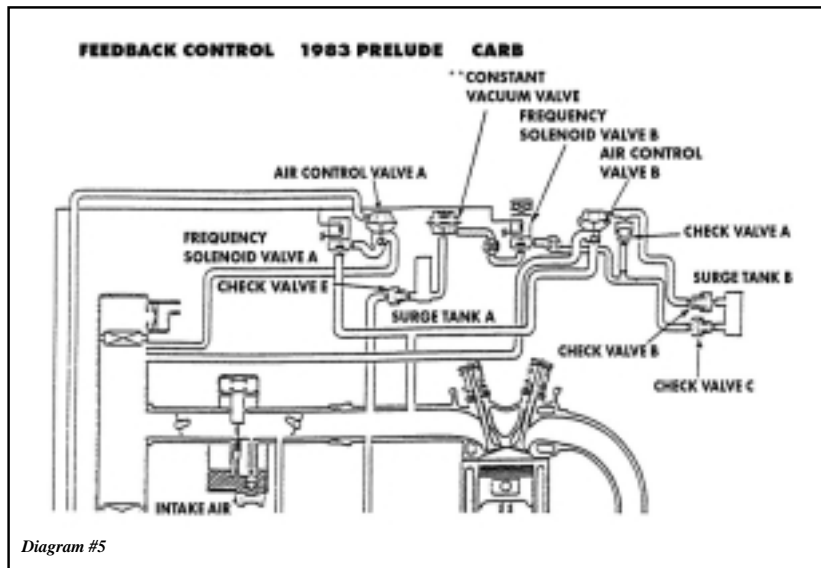
Diagram #5

If a constant vacuum valve fails where the vacuum control valves are exposed to full manifold vacuum, surge conditions can arise when the vacuum signal changes too quickly. If the valve fails where the control valves see no vacuum at all, few driveability problems would result, however, emissions and fuel economy will change for the worse.

Diagnosis can be accomplished by installing a vacuum gauge between the constant vacuum valve and the control solenoid it supplies. Carbureted vehicles should have a regulated vacuum range of 3.9 to 7.9 inches, while fuel injected vehicles should measure about 8 inches. Regardless of the system you are checking, the vacuum reading should be steady. If you have determined that the vacuum readings are out of specification, then replacement of the valve is necessary. These units are normally located in the emissions control box which is in the engine compartment (see diagram # 5).
