# PROBLEM Solver™ BULLETIN

## THE PROBLEM: SQUEAKING & CLUNKING NOISE FROM REAR TRANSVERSE SPRING ISOLATOR PADS

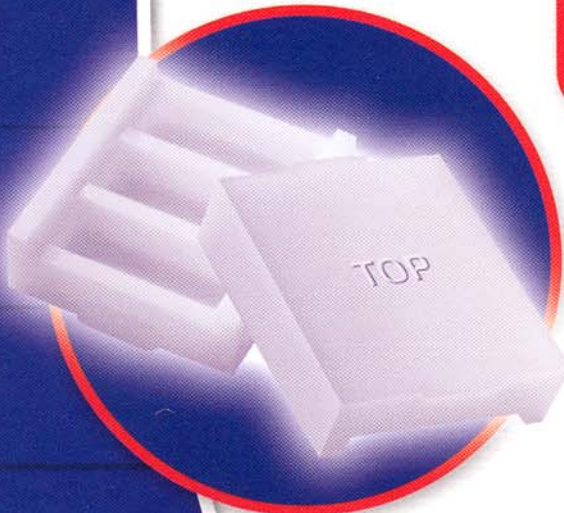
- Prematurely worn, torn or missing OE rubber pads, on some GM passenger cars, allow the composite spring to contact the metal spindle/knuckle which may cause a squeaking or clunking noise in the rear suspension.
- Extended contact will cause the transverse spring to crack and break, which may lead to bent or broken spindle rods.
- Ultimately, driver may experience poor ride/handling due to changes in rear suspension geometry.
- OE solution is an expensive, complete transverse spring and pad replacement.

## THE PROBLEM SOLVER: CARQUEST® TRANSVERSE SPRING ISOLATOR PAD

- Constructed of long-lasting composite materials.
- Eliminates squeaking and clunking noises in the rear suspension.
- Extends the life of GM W-Body transverse springs and supporting components. Prevents costly replacement of entire transverse spring if symptoms are caught early.
- Prevents costly replacement or repairs to the spindle rods and other suspension components. Saves time and money for you and your customer.
- Remove the excess rubber of the OE pad from the spring and insert the CARQUEST Isolator Pad into the pocket area of the spindle just as the OE pad does. The spring can be placed on top of the isolator pad within the spindle.
