PROBLEM Solver™ BULLETIN

THE PROBLEM: WHEEL SHIMMY & ROAD WANDER

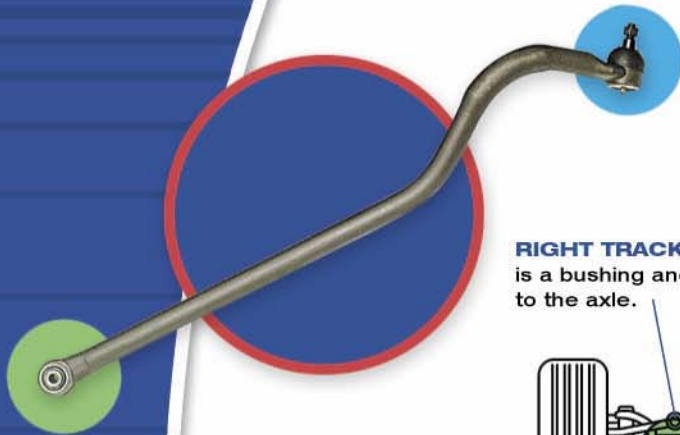
RIGHT TRACK BAR PIVOT is a bushing and attaches to the axle.

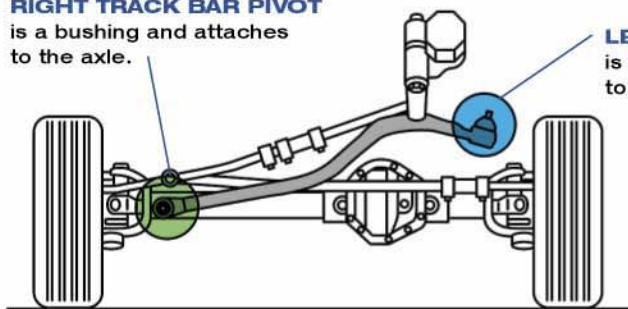
- Wheel shimmy and road wander on 1994–2001 Dodge Ram Trucks.
- Inspection performed according to OE guidelines may indicate that excessive movement in the track bar socket is responsible for these problems.

LEFT TRACK BAR PIVOT is a ball socket and attaches to the left frame rail.

- If there is more than .080" of play in the the ball socket, replace the track bar with the CARQUEST DS1413 or DS1256.
- Larger 1.25" full-ball stud, along with exclusive "gusher" bearings, combine to give the joint greater load-carrying capability and increased wear resistance. This creates a stronger pivot that can handle the lateral loads generated by the Dodge Ram tire and wheel assemblies.
