Solver™ BULLETIN

THE PROBLEM: PREMATURE WEAR OF UPPER BALL JOINT/ CONTROL ARM

THE PROBLEM SOLVER: CARQUEST® UPPER BALL JOINT/ CONTROL ARM

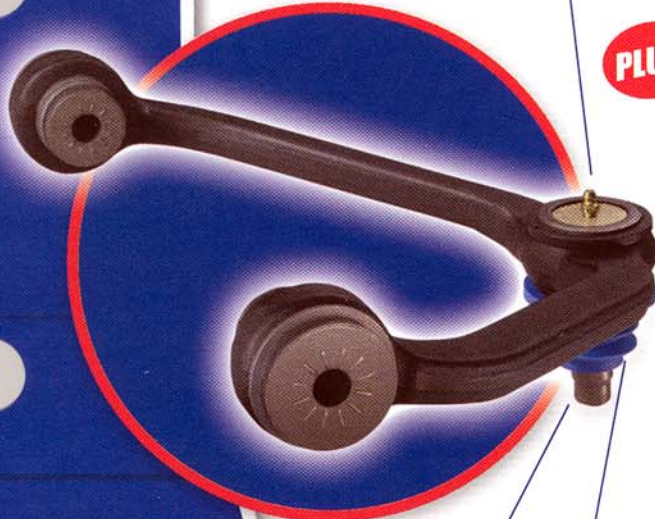
Ball joint with full-ball configuration metal stud and double bearing with exclusive "gusher" design.

10° extra stud swing

Polyurethane dust boot with directional grease release
