Solver™ BULLETIN

THE PROBLEM: PREMATURE BALL JOINT WEAR

THE PROBLEM SOLVER: CARQUEST® BALL JOINT

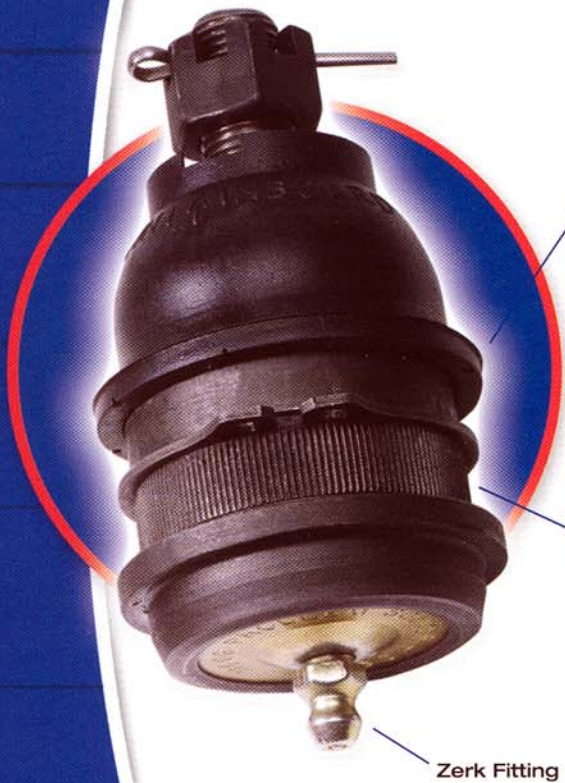
- Premature ball joint wear is experienced on the Hyundai Accent, Elantra and Tiburon.
- Intrusion and boot failure could accelerate ball joint wear.

- Greasable design to reduce friction and flush contaminants.
- Boot with directional grease relief is pressed on for a positive seal.
- Serrated housing accommodates slightly worn control arm housing for easy installation.
