Bulletin CQB 02-03

Subject: Diagnosing a sinking brake pedal on Teves 20 Anti Lock Brake System (ABS) Equipped, Import and Domestic Vehicles

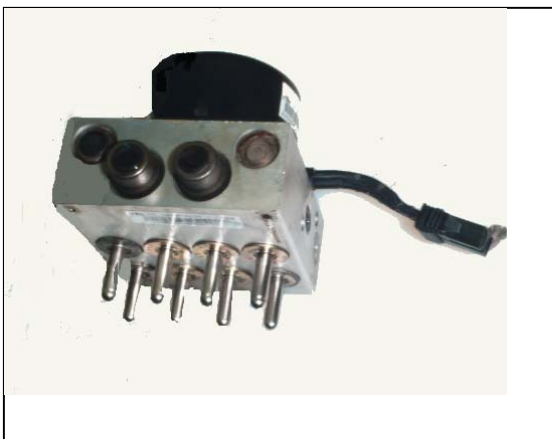
Condition: The Teves 20 anti lock braking system incorporates accumulator test ports. Two black plugs seal the accumulator chambers, permitting easy test access.

Repair Procedure: Technicians should confirm that the base brake system has no leaks or air in the system. Review bulletin **CQB 00-06** for low brake pedal isolation procedures. Technicians may then test the ABS hydraulic modulator accumulator function. Locate the two black accumulator plugs. See Fig. 1 below. Remove the small rubber plugs, (approximately ½ inch in diameter). Insert a paper clip into the access hole. Have an assistant start the engine and then apply the brake pedal. If the paper clip moves, the dump valve is stuck open allowing brake fluid to bypass into the spring-loaded accumulator(s). See Fig. 2 below. Test both accumulator pistons for movement. If either accumulator piston moves or leaks fluid out, the hydraulic modulator is defective.
