Solver[™]
BULLETIN

BULLETIN: 25943

Damaged bolt and/or bushing

Honda Multi-Link Front Suspensions

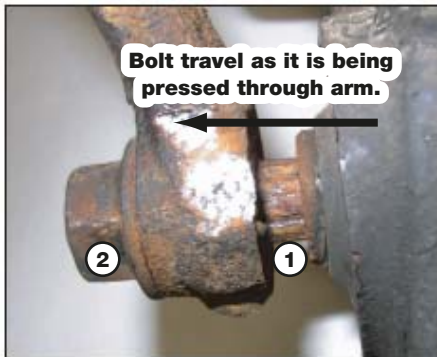
- When servicing struts or drive axles on Honda Multi-Link suspensions it is usually necessary to remove the wishbone from the lower control arm. It is very common for the pivot bolt to seize in the wishbone and/or bushing sleeve due to corrosion. Pressing the bolt out during removal can damage the wishbone and in most cases severely damages the bolt and bushing, prohibiting them from being reused.

1. Bolt breaking free from bushing sleeve.
2. Caution: If bolt is still frozen to wishbone, it may cause the fork to spread apart as pressure is being applied to bolt. This is clearly visible here by the gap between the bushing and wishbone.

- Only CARQUEST Chassis provides a complete service kit, containing a new bushing, zinc-plated serrated bolt and prevailing torque nut, to repair corroded wishbone pivots.
