# PROBLEM SOLVER™ BULLETIN

BULLETIN: 25947

## Premature Ball Joint Wear

Ford Econoline Vans 1992–2004

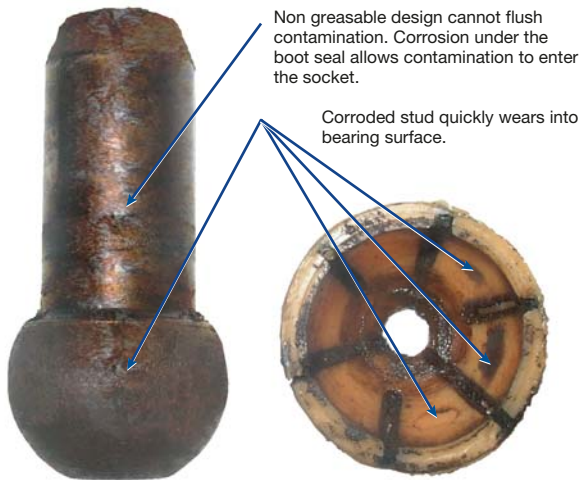
#### Non-serviceable joints experience premature wear in harsh fleet environments

- Requirements of fleet vehicles in the service and delivery industry impose severe demands on Ford E-Series van suspensions. Non-serviceable parts cannot support these harsh demands.

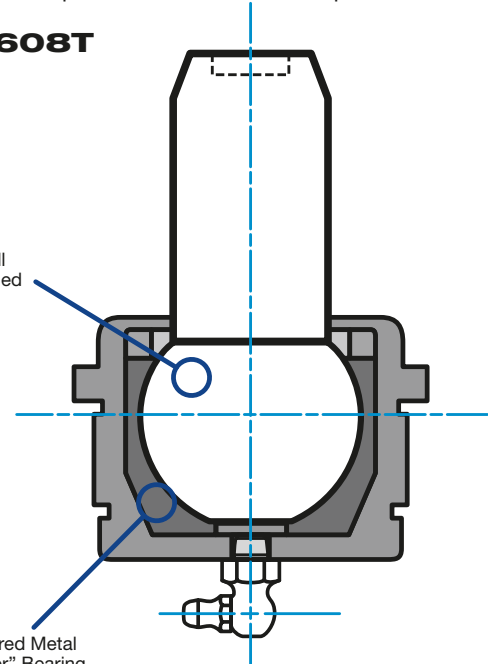
#### K8608T

Full Ball Hardened Stud

Powdered Metal "Gusher" Bearing

- The CARQUEST Chassis greaseable K8608T, K8609T and K8611T ball joints use hardened powdered metal bearings providing the most durable bearing surface available for fleet applications.
- A premium polychloroprene boot with a special grease relief valve, a patented assembly process and premium materials provides the most durable part available.
