# Bulletin ServiceLink<sup>SM</sup>

Bulletin SL5-96

## SERVICING HONDA MULTI-LINK SUSPENSION CV DRIVE SHAFTS

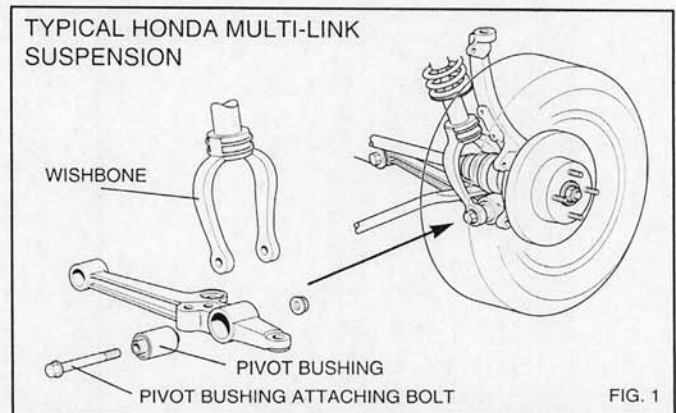
To service the drive shafts, the shafts must be removed from the vehicle. The complete drive shaft will not fit through the wishbone which connects the strut to the lower control arm. The normal service procedure is to disconnect the wishbone at the control arm and strut, figure 1.

The problem is the bolt that connects the wishbone to the control arm runs through a rubber bushing. The bolt often seizes to the inner sleeve of the bushing; forcing the bolt to turn can destroy the bushing. Replacing the bushing may require replacing the control arm, depending on the model and year.

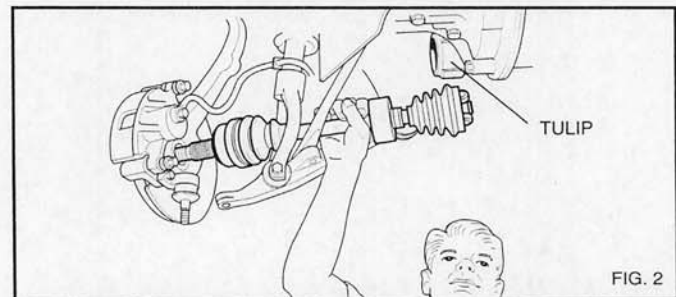
An alternate service procedure is to disassemble the inner CV joint. Begin by performing the normal steps of loosening the axle nut, separating the lower ball joint and starting the outer joint back through the hub. Then remove the large diameter clamp on the inner joint and slide the tripod out of the tulip by pulling the strut/hub assembly outward, figure 2. Be sure to hold the tripod rollers to keep them from falling. Finish separating the outer joint from the hub and then pull the shaft through the wishbone to remove it from the vehicle, figure 3.

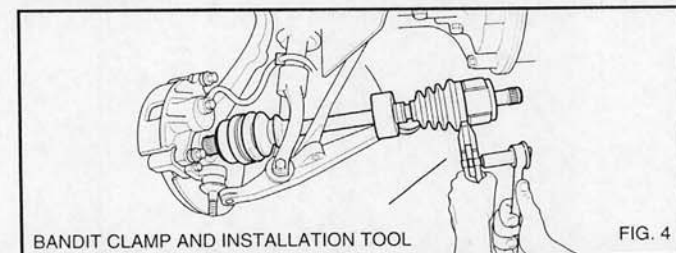
To install the drive shaft, reverse the procedure. Insert the inner joint, less the tulip, through the wishbone. Start the outer joint into the hub. Then refill the tulip and assemble it to the drive shaft. Position a new clamp on the boot and crimp it. A universal "Bandit" clamp is shown in figure 4.
