## H 6 Series Compressor Body Leaks

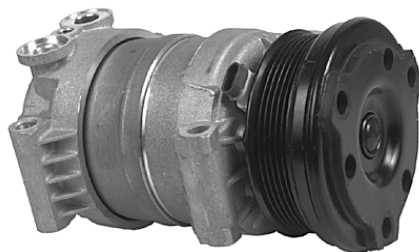
- Single solid bracket –Typically used with the HT6 – There have been some stories of these brackets warping. Most of these brackets are of cast aluminum so warping would be difficult. However, if the bolts are improperly torqued, as the bracket material is heated and cooled in the engine compartment, the bracket and the compressor would conform (twist or warp) to each other. If the bolsters or pads of the cradle that the compressor sits on are not 100% square and if the compressor does not lay flat on all four pads, a twisting or rocking action could present a problem even if the compressor is properly torqued. If the compressor does not sit solidly on all four positions, and the compressor is torqued down into the mounting cradle, the non-doweled compressor body will twist and invariably leak or make noise

To assure a solid fit, place the compressor in the cradle and try to rock it. If the compressor rocks back and forth, place a shim or standard washer between the compressor and the bracket. Torque the four bolts evenly and alternately but make sure the compressor does not rock in the cradle before the bolts are torqued.

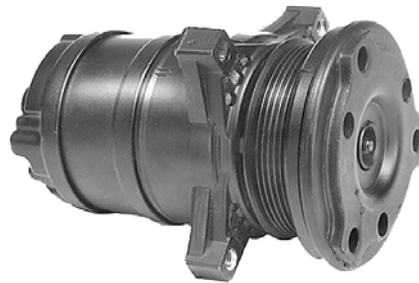
- Dual bracket – used with DA6, HD6 and HR6 – Most installers will start the four compressor mounting bolts and then use an air ratchet to tighten them down. If there is any alignment variation between the two brackets, the tightening process will twist the case and create a body leak or noise. To assure that the brackets conform to the compressor and not the compressor to the brackets, loosen the brackets from the engine block. Snug down the compressor mounting bolts. Tighten the bracket to engine bolts then torque the compressor mounting bolts.

Not only will the above procedures prevent body seal leaks but will also obviously increase the compressor life span, plus reduce vibration and noise. Any major amount of twisting of the compressor housings will cause the cylinders to be out of alignment. This alignment condition may not be enough to see with the naked eye but will cause decreased performance and decrease the life of the compressor. This compressor family was designed without an alignment dowel pin, allowing for a small amount of case twisting to occur. Possibly the OEM designer removed the pin for easier assembly purposes, since they did not consider it to be critical to this particular family of compressors. However, a moderate amount of case twisting will typically lead to a case leak, and if not quickly detected, it will possibly cause compressor failure.
