Bulletin SL5-94
© 1994 Moog Automotive Inc.

POSSIBLE UPPER BALL JOINT FAILURE 1988-94 CHEVROLET & GMC 4X4's

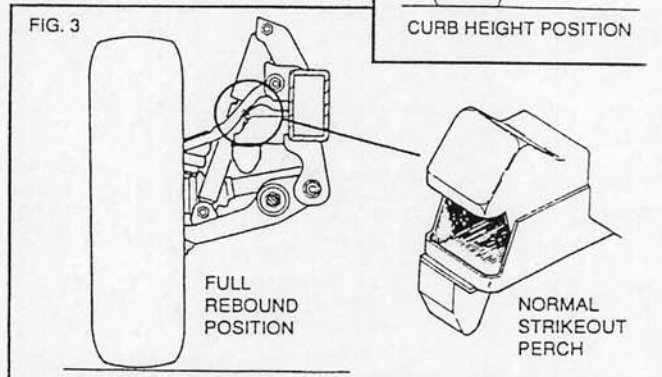
If a strikeout perch shows evidence of sustained contact or damage, fig 4, further investigation is required.

- Check the shock absorber for damage and for correct extended length. If the extended length is more than 16.5", the shock absorber must be replaced with a unit that meets OEM specifications.
- Measure as shown in fig. 4. With the suspension in full rebound, a vehicle with an OEM shock absorber and strikeout perch in good condition will measure 23.5" maximum from the center of the wheel to the underside of the fenderwell.
- Check that the vehicle curb height is correct.
- Check for damage to upper control arm. Note: If the above factors are not inspected or corrected, ball joint failure could result.
