TechPro Bulletin

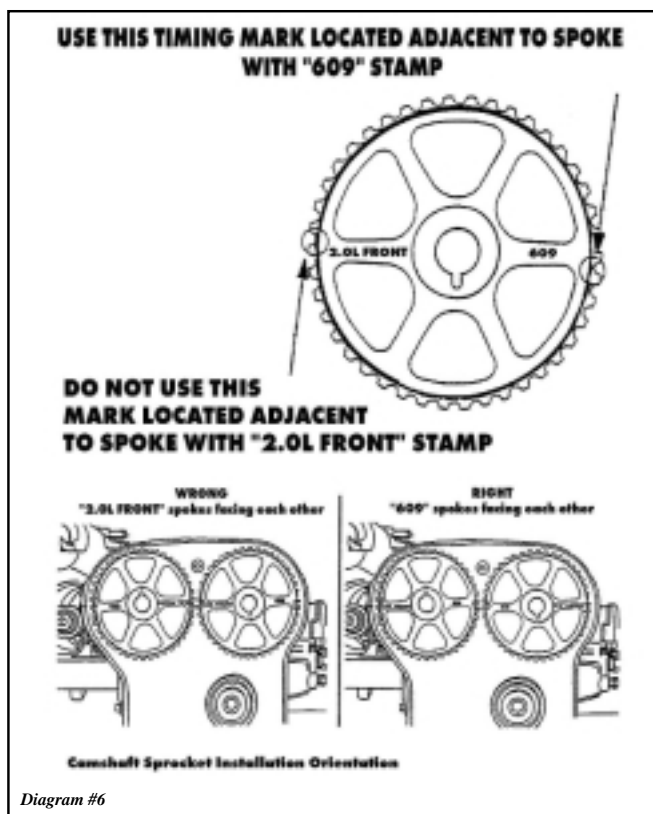
Use caution when servicing the camshaft sprockets or timing belt on the '95 Eclipse with the 2.0L non-turbo engines. Some of these engines have two timing marks on each cam sprocket. When installing the timing belt, set the crankshaft sprocket to TDC by aligning the mark on the sprocket with the arrow on the oil pump housing. Next, set the camshafts' timing marks together by aligning the marks on the sprockets. Make sure to use the mark that is closest to the "609" designation on the gear. DO NOT use the mark that is closest to the "2.0 L front" designation. Engine damage may result if the cams are incorrectly set.
