# Bulletin ServiceLink<sup>SM</sup>

Bulletin SL10-96

## CV SHAFT REMOVAL, LIGHT DUTY 1996-88 "K" SERIES GM 4X4

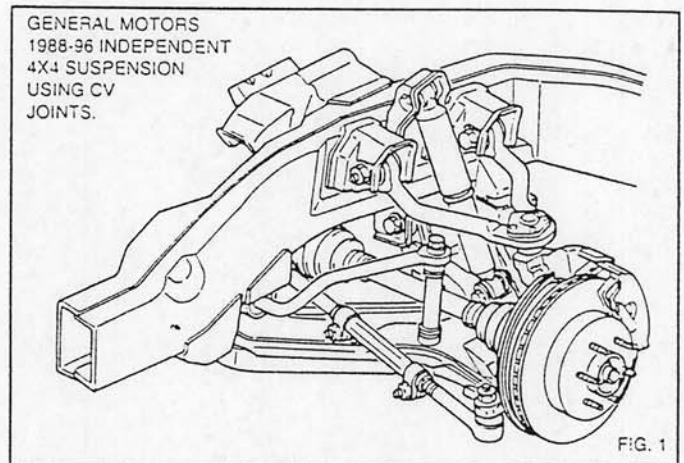
The normal service procedure to remove the front drive shafts on these vehicles involves separation of both the upper and lower ball joints, figure 1. This is necessary to provide sufficient clearance to remove the steering knuckle, figure 2. The average time to remove the ball joint stud nuts, separate the ball-joint tapers and clear the steering knuckle is one half hour. In areas where rust and corrosion levels are high the labor time to separate ball joints can potentially be longer.

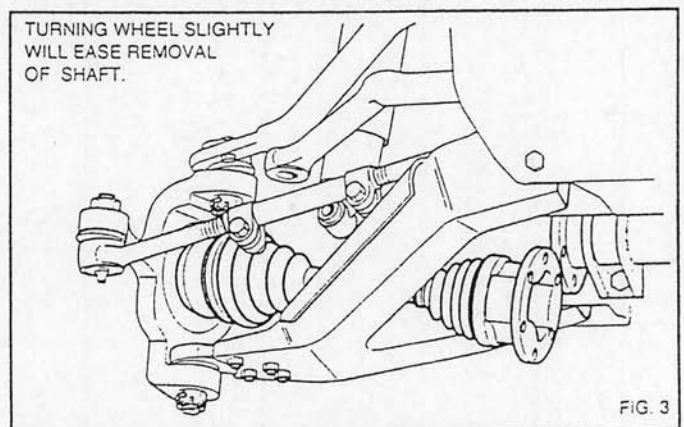
After the axle nut is removed, support the control arm, disconnect the lower shock absorber mount and push the shock up out of the way. Remove the bolts holding the inner joint to the output shaft flange. Compress the inner joint so it can be moved down, and out through the center of the lower control arm, between the control arm and frame. Slide the outer joint out of the hub and remove the drive shaft for service, figure 3.

To install the drive shaft reverse the procedure described above. Torque the inner joint flange bolts to 60 foot pounds. Reconnect the shock absorber and torque it to 66 foot pounds. Torque the drive shaft hub nut to 175 foot pounds.
