# Bulletin ServiceLink<sup>SM</sup>

Bulletin SL10-97

## SERVICING AEROSTAR UPPER BALL JOINTS

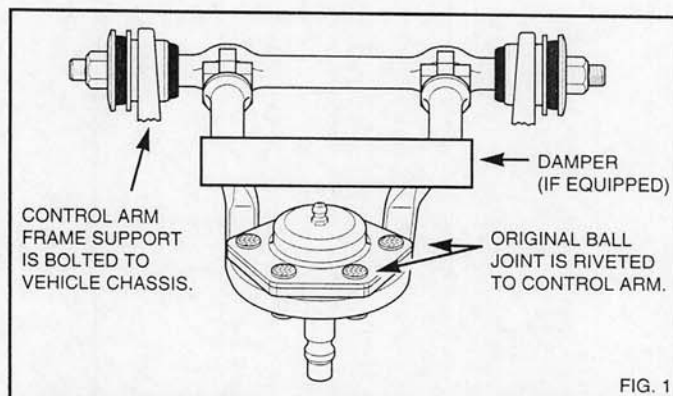
1986 through 1996 Ford Aerostar upper ball joints are riveted to the control arm, figure 1. The manner in which the control arm is connected to the vehicle makes it easier to service the ball joints without removing the control arm from the vehicle. Some vehicles are equipped with a "bolt on" damper, also shown in figure 1. This damper does not effect ball joint service.

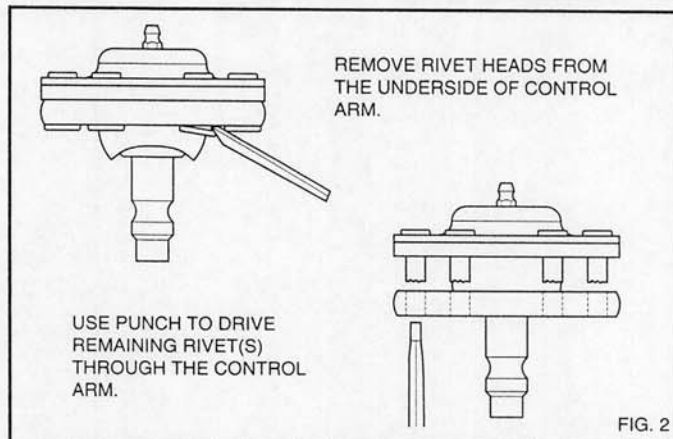
The rivets holding the ball joint can be removed by drilling through the rivets or using a chisel to remove the rivet head and then use a punch to drive the rivets out, figure 2.

The rivets have a slight taper and are more easily removed if they are driven out from the underside of the control arm. You can prop the arm up in a position that allows you better access to the lower rivet heads. When using a chisel be careful not to damage the control arm. The ball joint will often become free of the control arm with the rivets still partially in the original ball joint housing.

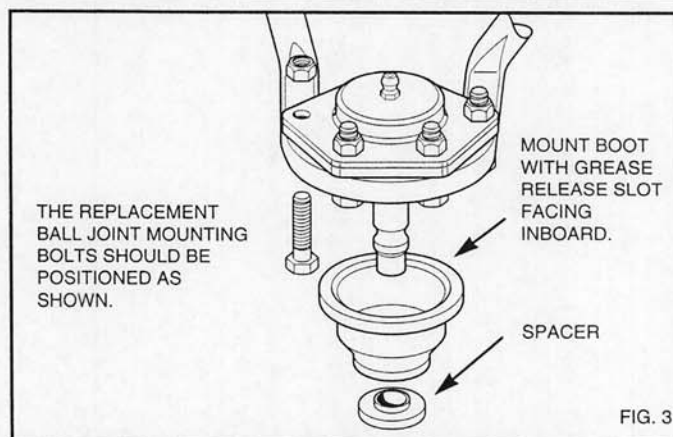
During reassembly be sure the holes in the control arm are in good condition. Position the mounting bolts as shown in figure 3 with the attaching nuts on the top side of the ball joint. Torque the nuts to 14 to 19 foot pounds. When connecting the ball joint stud to the knuckle use the new pinch bolt and nut provided and torque to 27-37 foot pounds.
