# TECHNICAL SERVICE BULLETIN

1981-1989 Escort/Lynx with A/T  
1984-1993 Tempo/Topaz with A/T and 2.5L  
1986-1994 Taurus/Sable with A/T and 2.5L

Removing left side drive axle

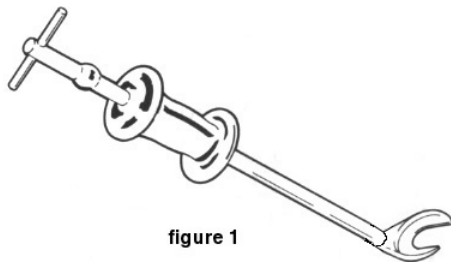
figure 1

On these applications the right axle must be removed before attempting to remove the left or driver's side axle. The Ford tool number T86P-3514-A2 (slide bar puller)(fig. 1) makes it easier to remove the right axle.

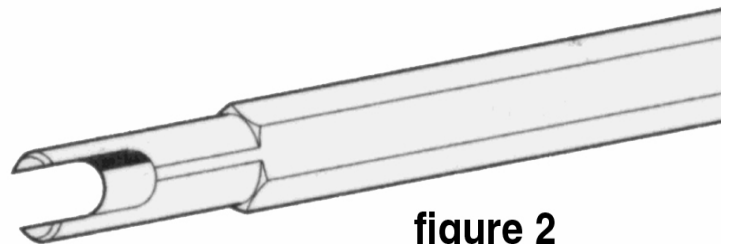
figure 2

Do not try to drive the left axle out of the differential from the right side with a punch or similar tool because it often peens over the head of the axle stub locking it into the side gear. The appropriate Ford tool or one similar to the OTC # 7140 pictured below (figure 2) will do an excellent job of pushing the left axle out of the differential. If this tool is left in the differential until you replace the axles then you do not need to install shipping plugs (T81P-1177-B) in the side gears.

**CAUTION:** If the side gears move then the transaxle must be removed to realign the side gears.
